# Aviation Investigation Preliminary Report

<b>Location:</b>	Deer Harbor, WA	<b>Accident Number:</b>	WPR24FA184
<b>Date &amp; Time:</b>	June 7, 2024, 11:40 Local	<b>Registration:</b>	N268AF
<b>Aircraft:</b>	Beech A45	<b>Injuries:</b>	1 Fatal
<b>Flight Conducted Under:</b>	Part 91: General aviation - Personal

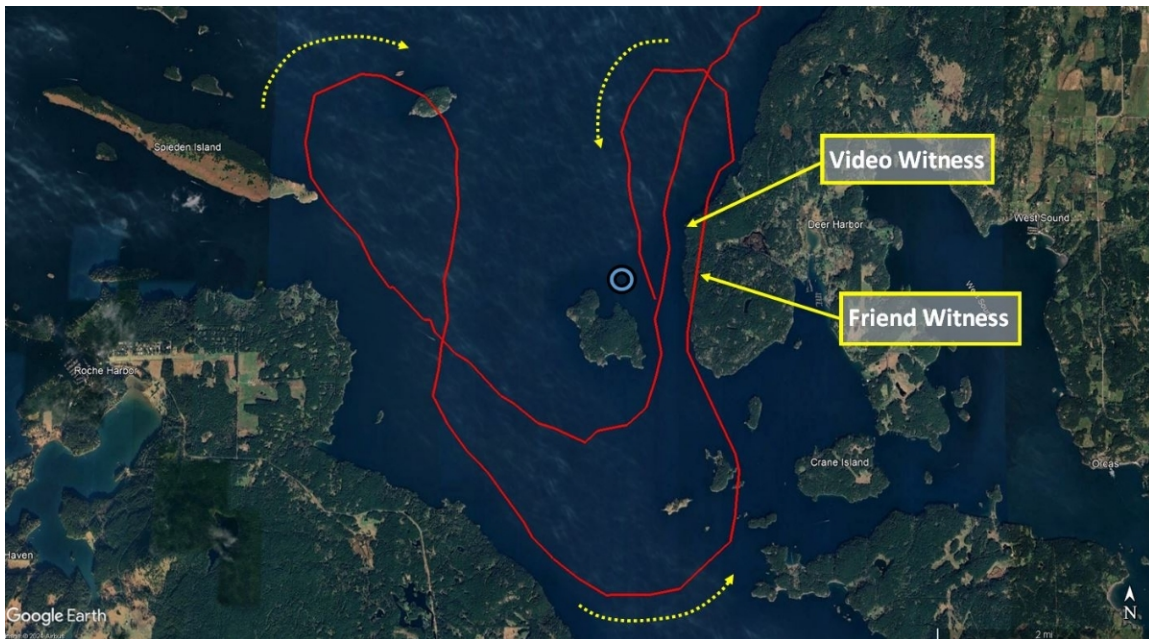
Over the next 9 minutes, the target flew a series of passes back and forth along the coastline of the San Juan Channel, and by 1137:30 it was heading north, along the west coast of Orcas

Island (see figure 1). The friend reported that about this time she could hear the familiar sound of his airplane, and a short time later she observed the airplane overhead traveling north along the shoreline in front of her house.

Figure 1 – Accident location. Red line indicates approximate track based on radar data; blue circle denotes location of main wreckage.

The fuselage was located about 1,700 ft west of the last radar target, in about 30 ft of water. Most of the wreckage was recovered from the channel during the following week and has been
