AOPA Baron (N202MD) arrived at GAMI in Oklahoma on Oct. 30, 2023, with 15 hours total TIS. At that time, the LH engine (2) began operation on G100UL and the RH engine (1) continued to be fueled and operate only on 100LL.

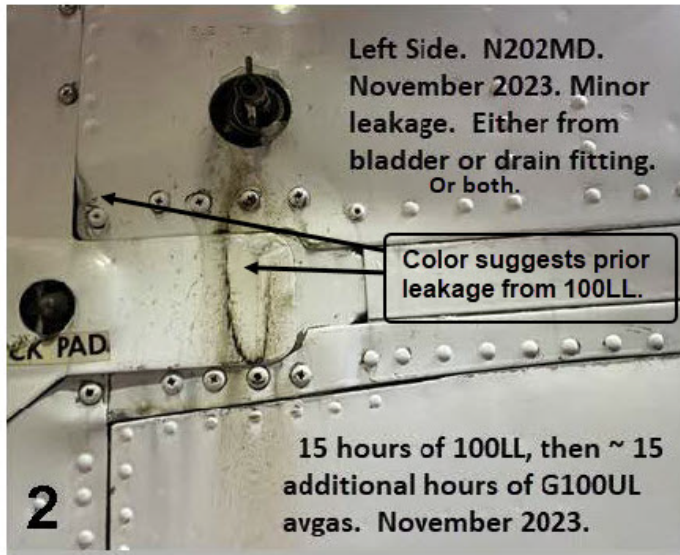
Photos (1) & (2) were taken a few weeks later, in mid-November. The fuel stains in the RH (1) tank were a result of leaks in that tank which had only ever been fueled with 100LL. At that same time, the LH (2) tank exhibited signs of leakage, but those appear to be residual leakage from previous use of 100LL (based on color of the stains).

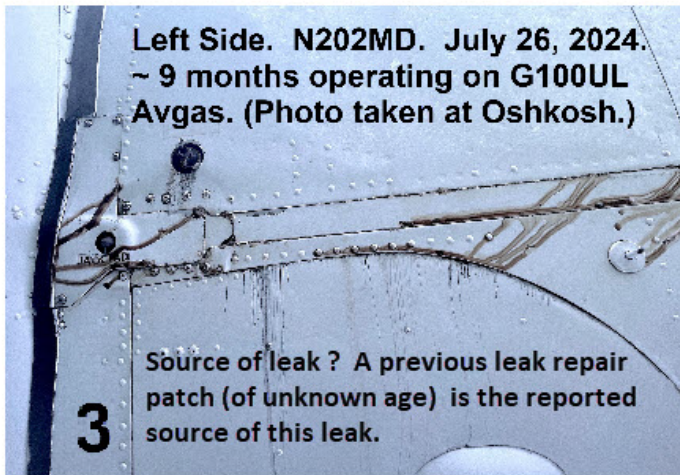
The LH fuel stains (3), observed 9 months later at Oshkosh, were investigated by AOPA and Kurt Hartwig of Eagle Fuel Cells. The maintenance shop now removing all four bladders reports that the source of the leak (3) is from a previous repair (patch). It is common for older Beech 40 gallon fuel bladders to have multiple "patches". When the fuel migrates to the bottom of the wing, the fuel (100LL or G100UL) then dissolves the adhesive bonding the "chafe tape" to the floor of the tank, and then leaks out and leaves a thick sticky residue and stain.

IMPORTANT: AOPA researched the log books. The LH (2) bladder was installed in 1974. It is 50 years old! The RH (1) bladder was installed in 1978 and is 46 years old.
