Aviation Investigation Preliminary Report

Location:	Austin, TX	Incident Number:	DCA24LA328
Date & Time:	September 14, 2024, 12:48 Local	Registration:	N442CV
Aircraft:	CIRRUS DESIGN CORP SF50	Injuries:	1 None
Flight Conducted Under:	Part 91: General aviation - Personal

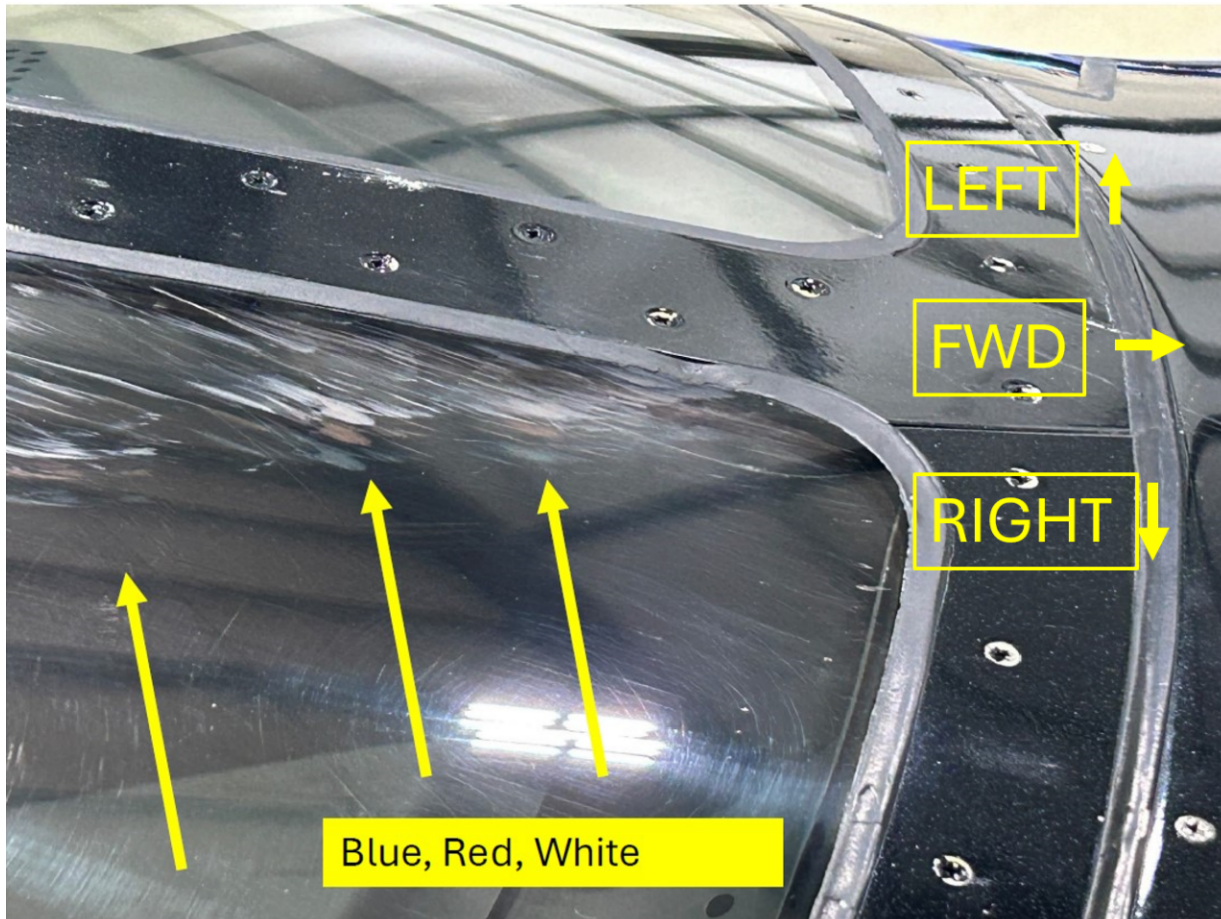
According to the pilot, during approach into AUS, he thought a bird struck the right windscreen and damaged the interior sun visor near the top. However, a photograph provided by the airplane manufacturer, Cirrus Aircraft, showed scraping and blue, red, and white color transfer marks that extended diagonally from the bottom of the right windscreen near the center post toward the top and outboard side the windscreen, see figure 1. The pilot reported that after landing, he wiped the airplane down and noted there was an “oily residue” on the windscreen. He did not retain any samples of the residue.

Figure 1. - Scrape and color transfer on windscreen (Source: Cirrus Aircraft).

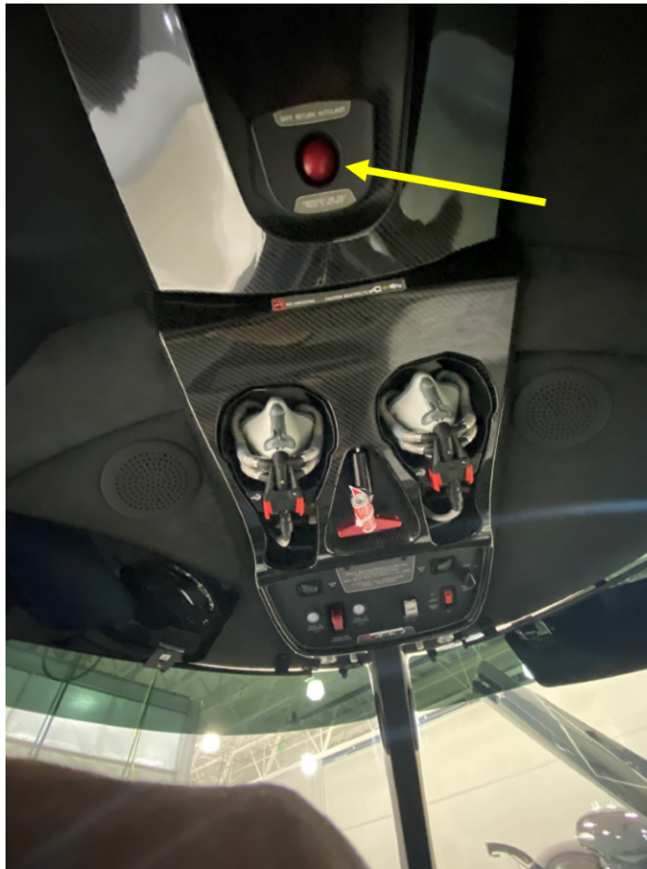
- 1) by pressing a pushbutton located in the center of the overhead console (about 2 ft aft of the top of the windscreen – see figure 2),
- 2) if the Automatic Level mode is engaged for 1 minute, or,
- 3) if the Emergency Descent Mode is active and the airplane descends through 15,000 ft.

Figure 2 . – Yellow arrow shows location of Autoland pushbutton (Source: Cirrus Aircraft).
