Aviation Investigation Preliminary Report

| Location: | Houston, TX | Accident Number: | CEN25FA019 |
| Date & Time: | October 20, 2024, 19:51 Local | Registration: | N881KE |
| Aircraft: | Robinson R44 | Injuries: | 4 Fatal |

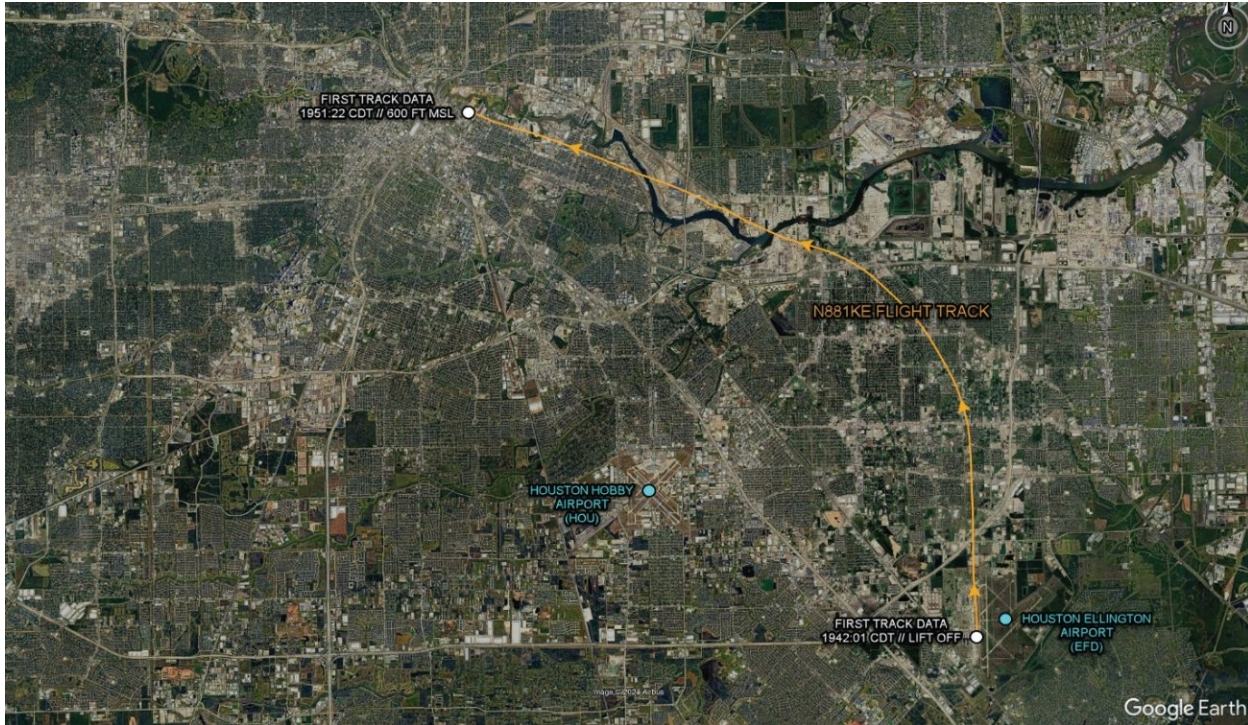
Figure 1. Overview of accident helicopter flight track.

According to preliminary Automatic Dependent Surveillance Broadcast (ADS-B) data and recorded air traffic control communications, the helicopter departed Ellington Airport, Houston, Texas, about 1942, and flew north, then northwest about 900 ft msl (see Figure 1). The pilot established communications with the local air traffic controller and requested the “downtown loop.” Several minutes later, the controller issued a traffic advisory for a company tour helicopter, N233JD. The accident pilot acknowledged traffic in sight on her ADS-B. The controller requested the accident pilot to maintain visual separation from the traffic, and the pilot was reading the instructions when the radio transmission abruptly ended. No further communications from the accident helicopter were received.

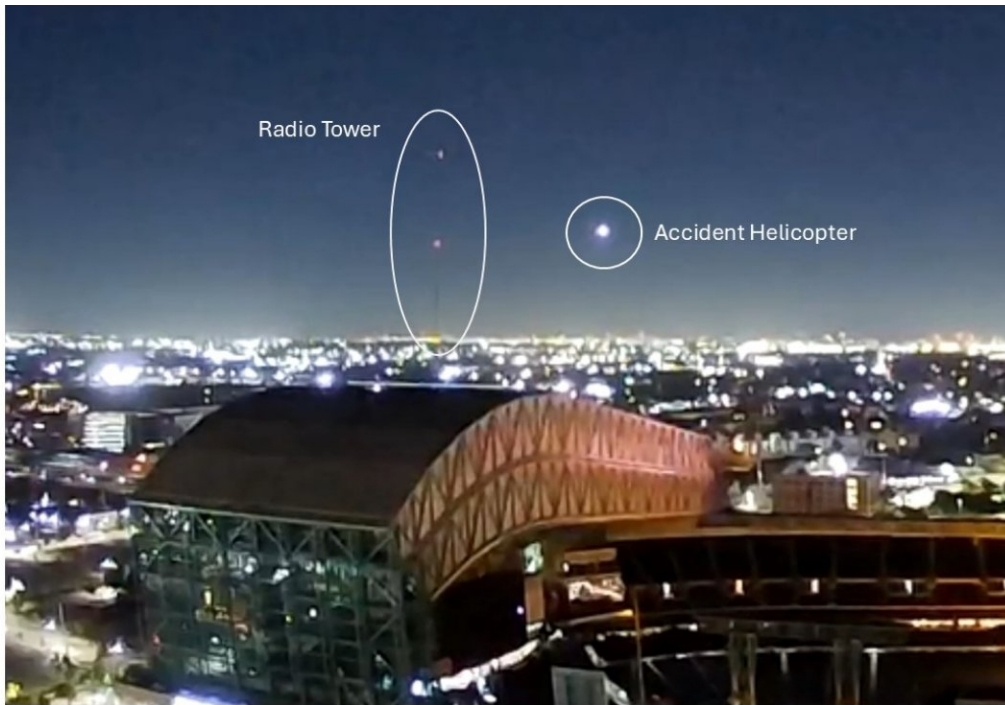
Figure 2. Surveillance video screenshot of accident helicopter approaching the radio tower. The tower's top and middle flashing beacons are visible in the screenshot.

Surveillance videos, several witnesses, and helicopter structure embedded in the radio tower indicated that the helicopter impacted the tower about 100 ft from the top of the 1,003 ft radio tower. The tower was equipped with flashing light beacons at 1,000 ft, 639 ft, and 340 ft from the surface. A surveillance video showed the tower's top and middle beacons flashing as the helicopter approached the tower (see Figure 2); the tower's lower beacons were not visible in the video.

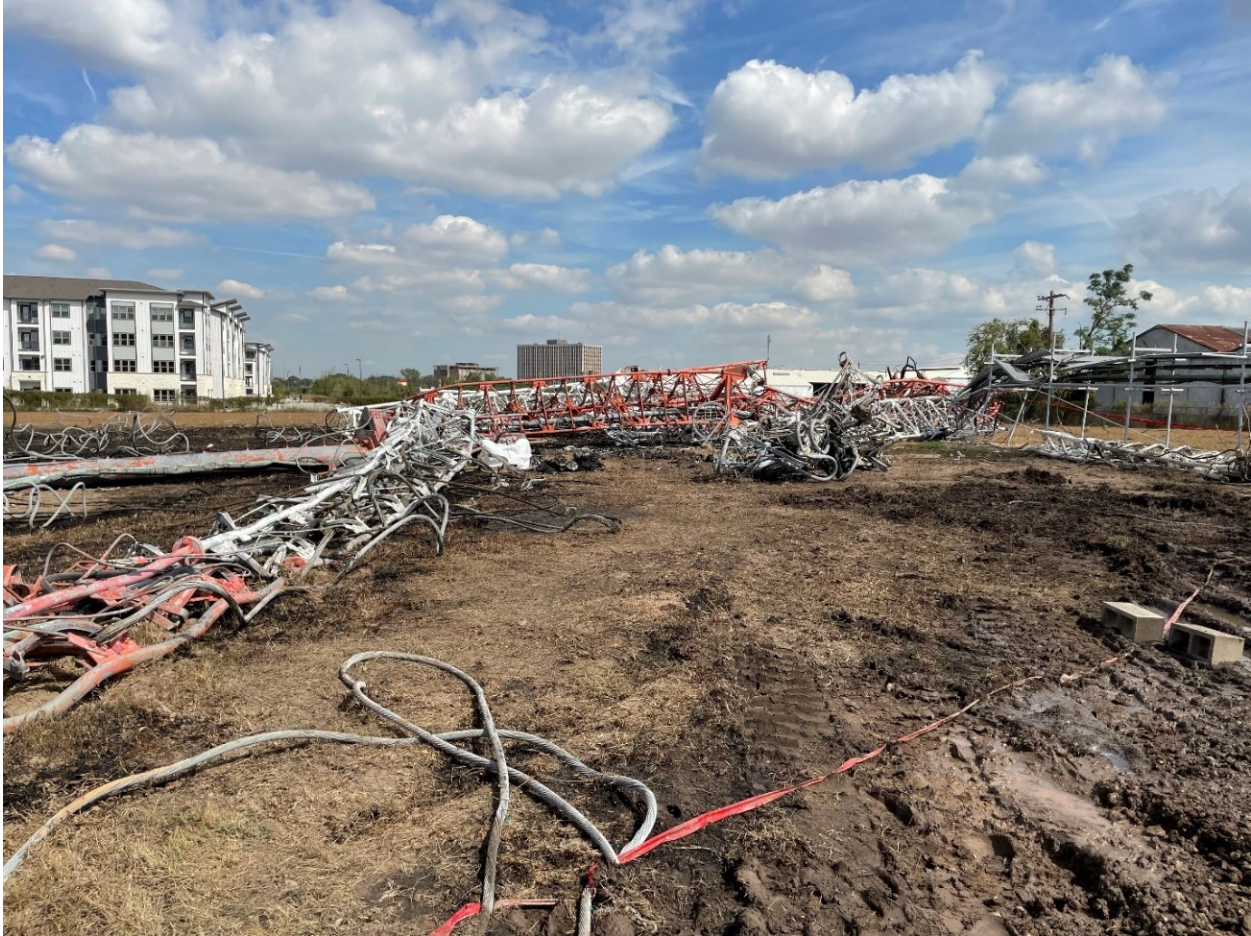
Figure 3. Accident site with collapsed radio tower.

During the impact with the radio tower, there was an explosion, and the helicopter fell to the ground. The radio tower collapsed onto the helicopter, and a post-impact fire destroyed the helicopter (see Figure 3).

The debris field measured about $\frac{1}{4}$ mile northwest of the radio tower and contained fragmented sections of plexiglass, main rotor blades, console components, upholstery, flight controls, and landing gear. Portions of the forward fuselage structure were found embedded in the radio tower structure about 100 ft from the top, consistent with the video and witness information.
