# Aviation Investigation Preliminary Report

<b>Location:</b>	Nome, AK	<b>Accident Number:</b>	ANC25MA018
<b>Date &amp; Time:</b>	February 6, 2025, 15:20 Local	<b>Registration:</b>	N321BA
<b>Aircraft:</b>	TEXTRON AVIATION INC 208B	<b>Injuries:</b>	10 Fatal
<b>Flight Conducted Under:</b>	Part 135: Air taxi & commuter - Scheduled

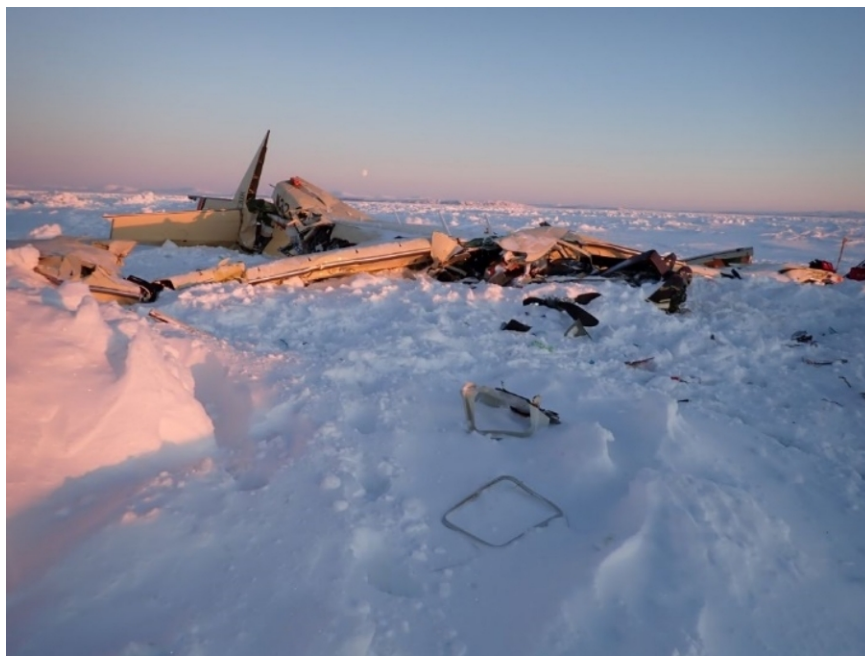
**Figure 1.** Accident site.

The airplane came to rest upright. The propeller assembly separated from the engine and was located adjacent to the wreckage. The engine cowling was dislocated and fragmented. The engine remained secured to the mount; however, both the engine assembly and the mount were damaged consistent with impact forces. The fuselage exhibited upward crushing damage along the entire length. Both wings were damaged, with the left wing being partially separated from the fuselage. Both wings exhibited leading-edge crushing damage along the entire spans. The outboard portion of the right wing was rotated aft and partially separated. An initial airframe examination revealed no evidence of an in-flight structural failure.
