Factual Information

History of Flight

On January 3, 2022, 1134 Pacific Standard Time, I departed the Riverside Municipal Airport (KRAL) with the intent of maintaining proficiency on takeoff and landings at the local airport I teach out of, Cable Airport (KCCB) on N76646, a Cessna 120.

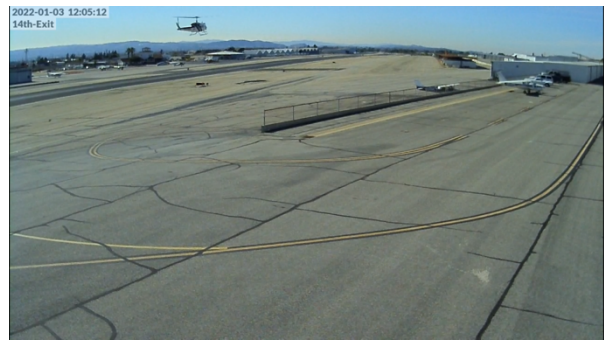
N306SB crossing runway 24

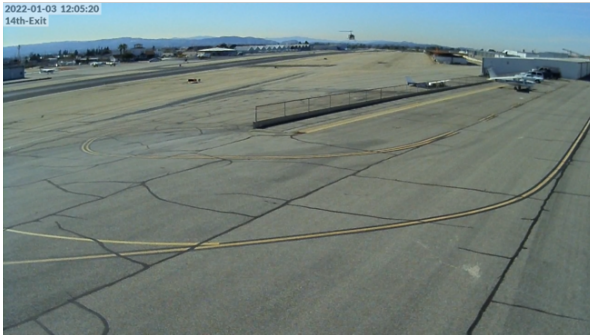
N306SB north of Runway 24

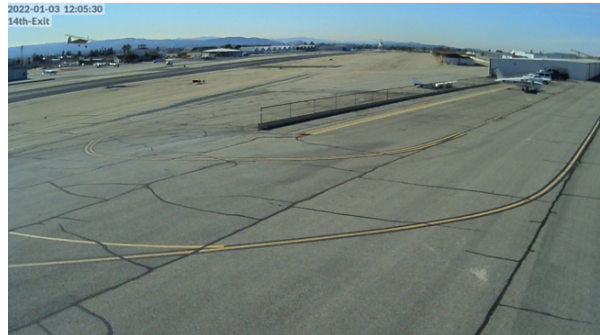
N76646 appears in Frame
(Aircraft is configured for Go Around, Full power)

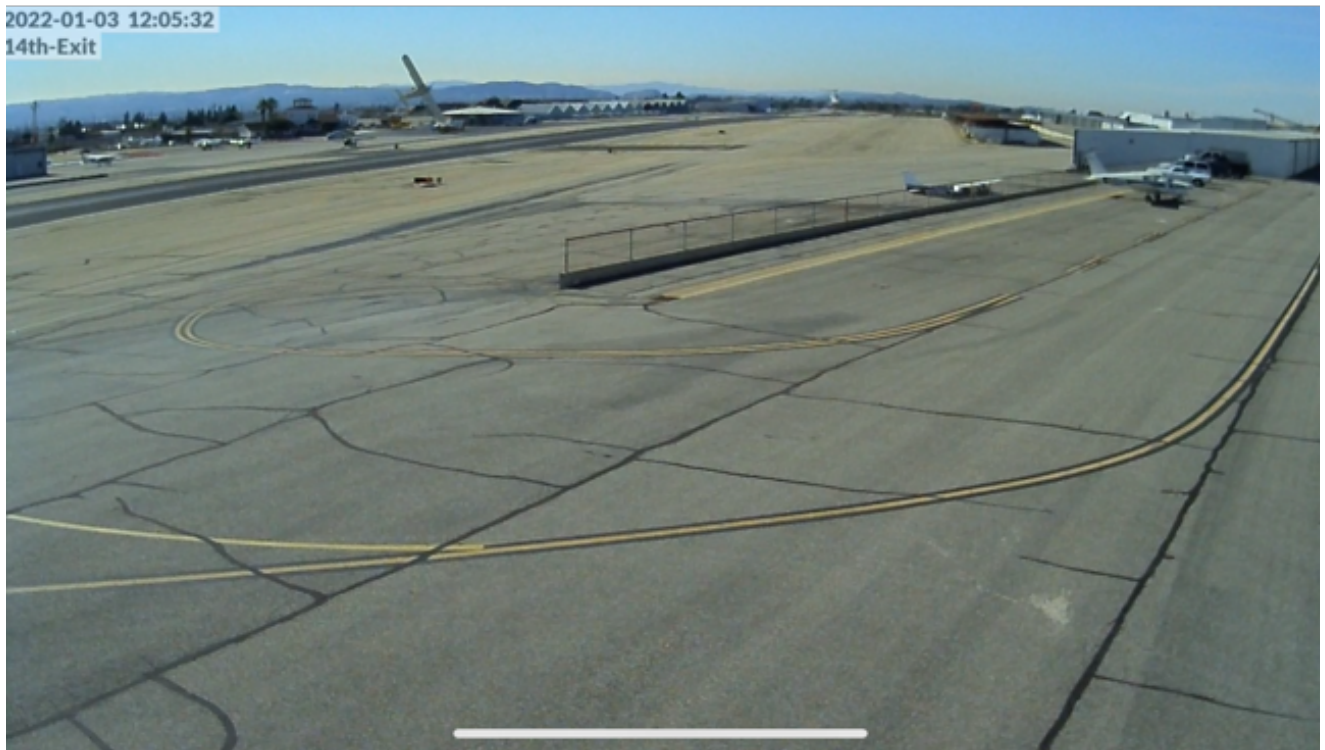
N7746 experiencing the effects of the rotor wash left behind by N306SB

On January 3th, 2022, 1205 Pacific Standard Time, a Cessna 120 airplane, N76646, impacted the asphalt north of runway 24 at Cable Airport in an attempted go around. Loss of Control can be attributed due to Rotor wash from N306SB, a San Bernardino Sheriff's Huey Helicopter who did not announce intentions of crossing runway 24, crossed an active runway when the pilot of N76646 was on final. The rotor wash did not allow for the safe execution of a go around.

This accident could've been prevented if the operator of N306SB followed the noise abatement procedures for the Cable Airport. By avoiding a long straight in approach that set up the helicopter south of the extended centerline, and instead entering traffic pattern like other aircraft, this would've helped with the flow of traffic and separation. It is unclear if N306SB had intents of landing, or purpose of their flight or operations, but if they wanted to use the runway, they should broadcast their intentions on the CTAF like everyone else.

Recommendation to the Airport Operators, standardizing an approach to the helipads that is out of the flow of fixed wing traffic is a possible way of preventing this accident.

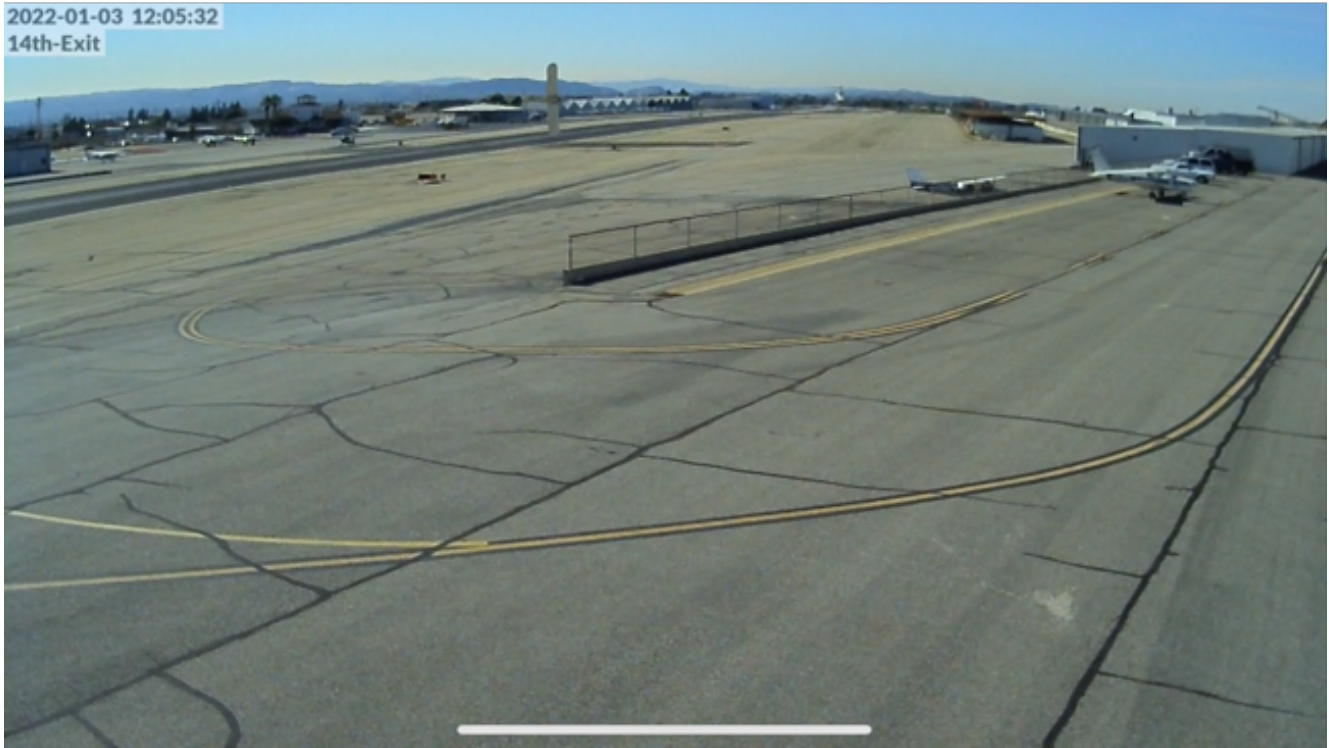
1 Second before right wingtip impacted with the surface.

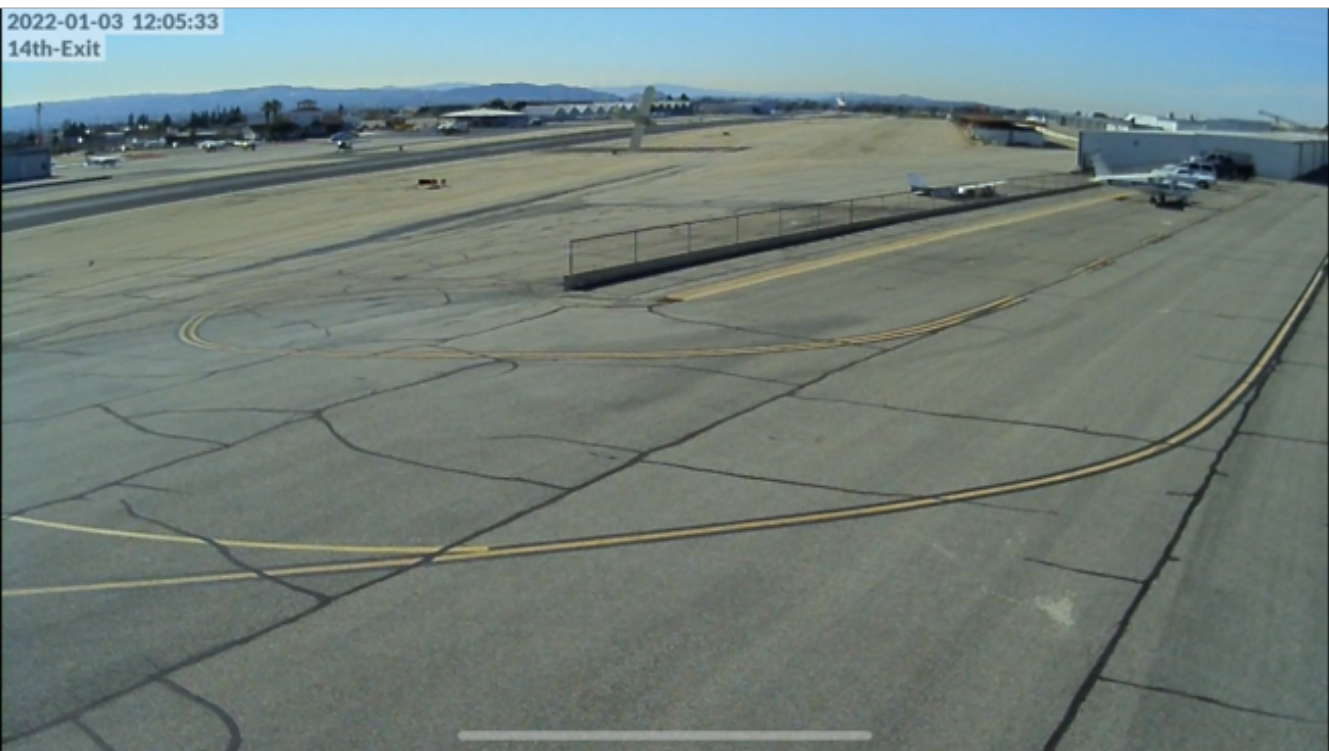
Moment of impact of right wingtip.

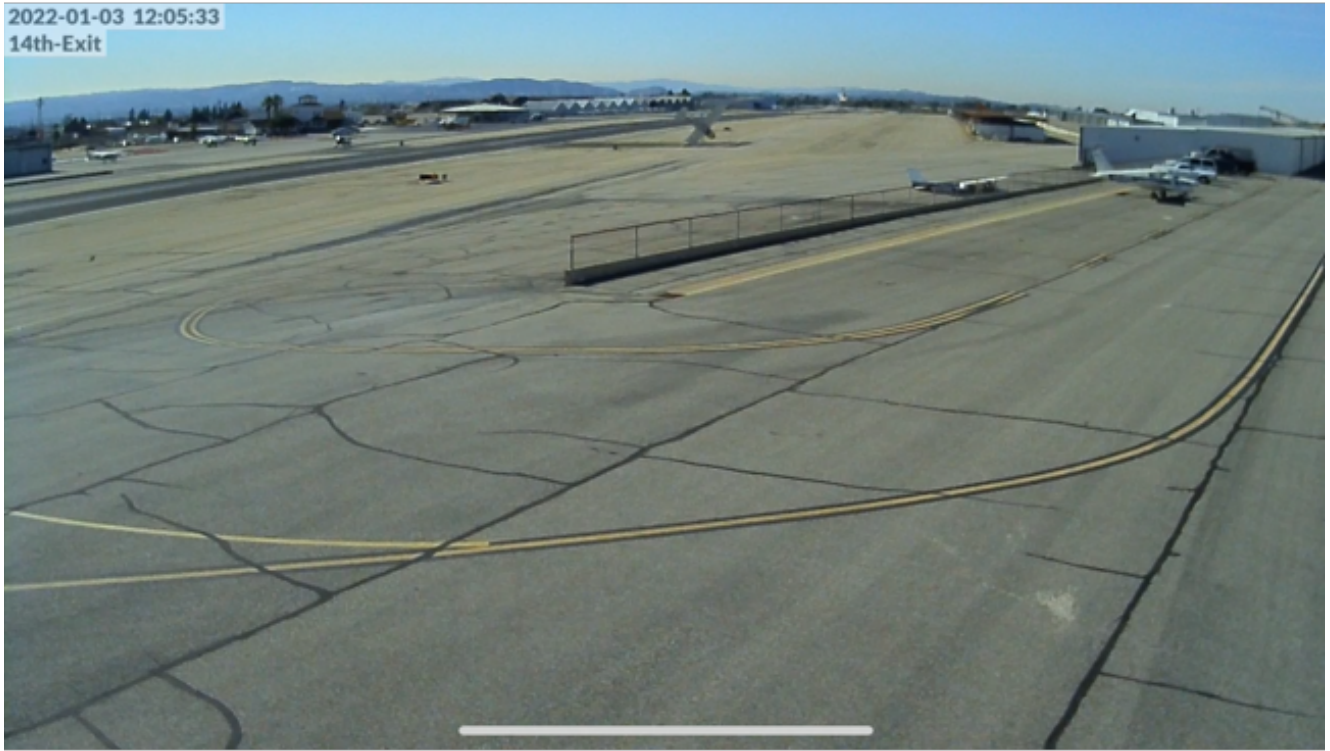
Right Wingtip and right main gear impacting the ground

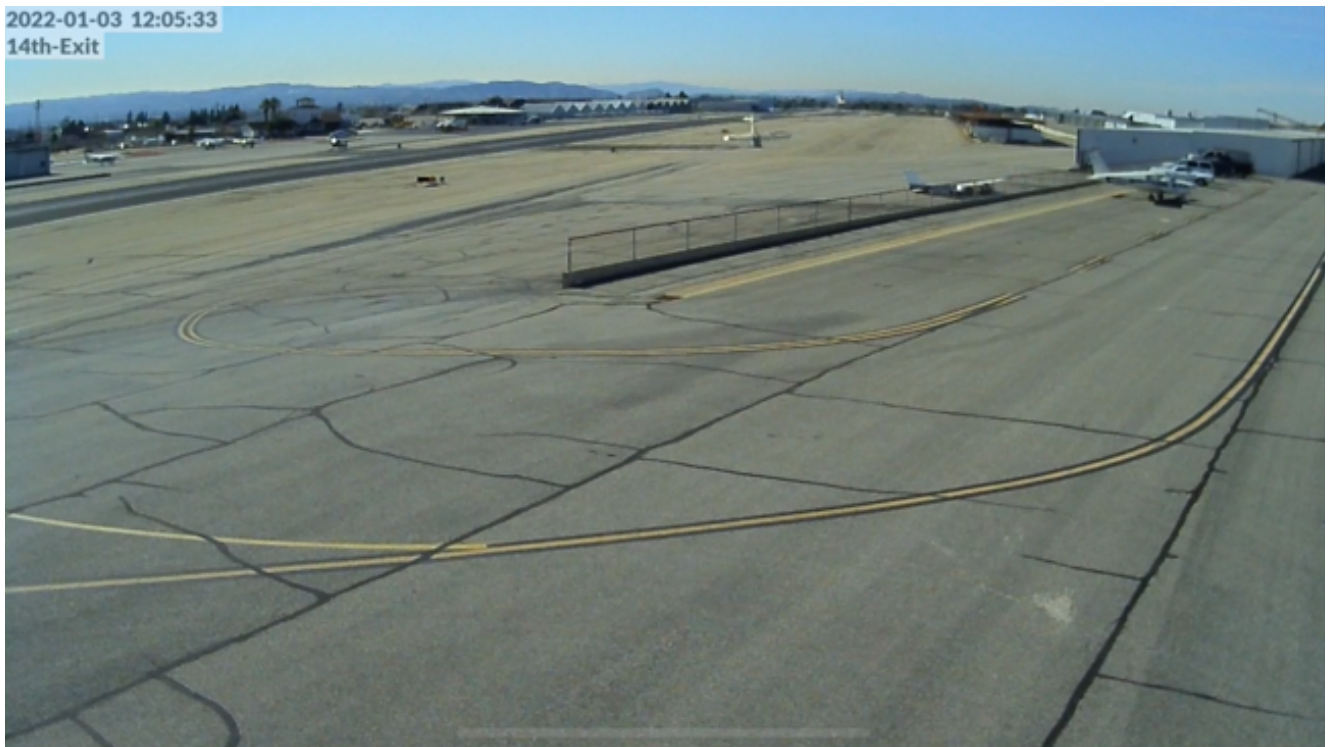
Propeller impacts the ground

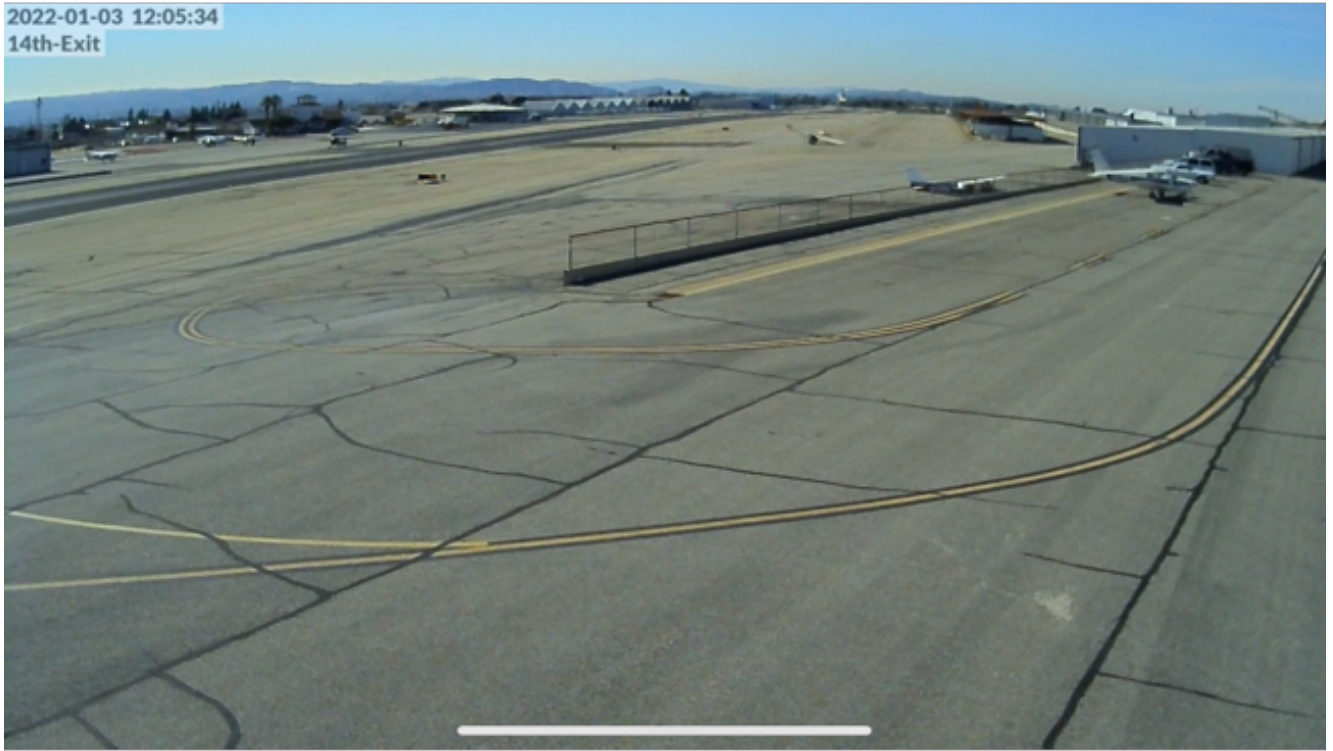
Aircraft “cartwheels” over

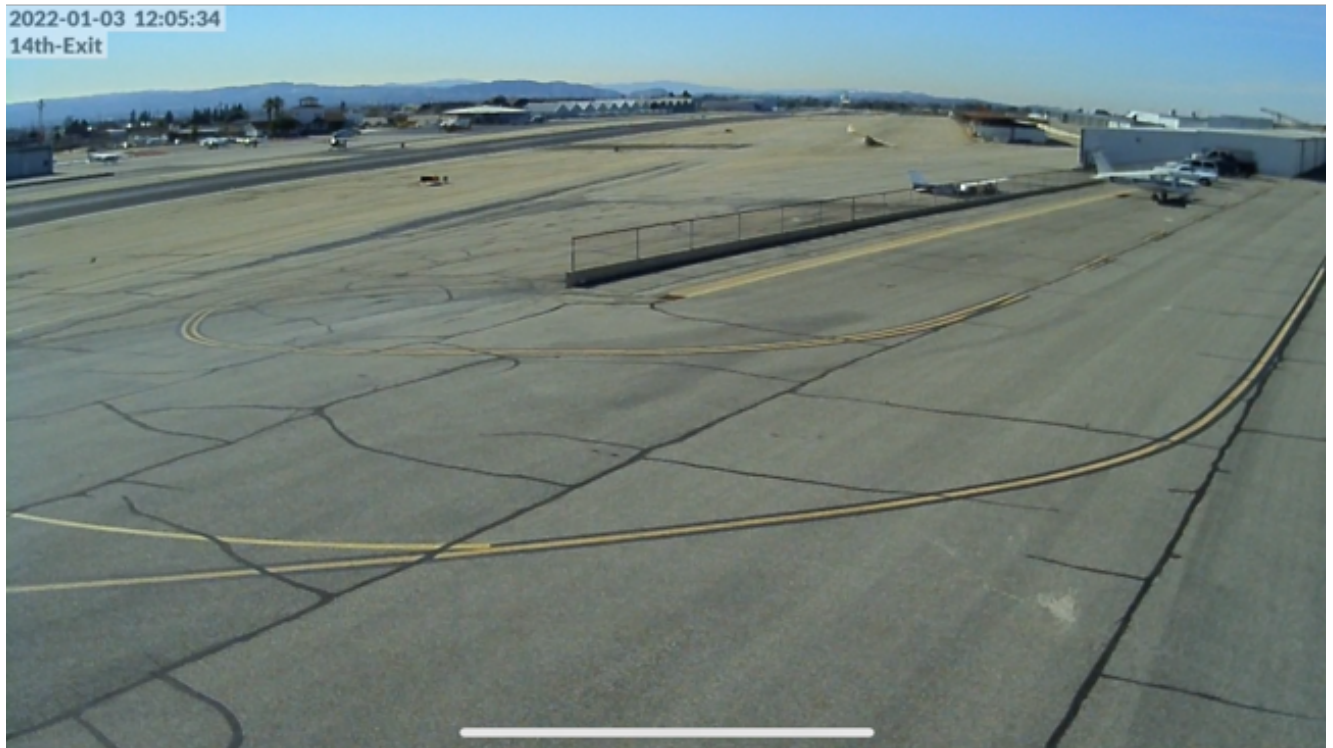
Energy keeps the airplane sliding down

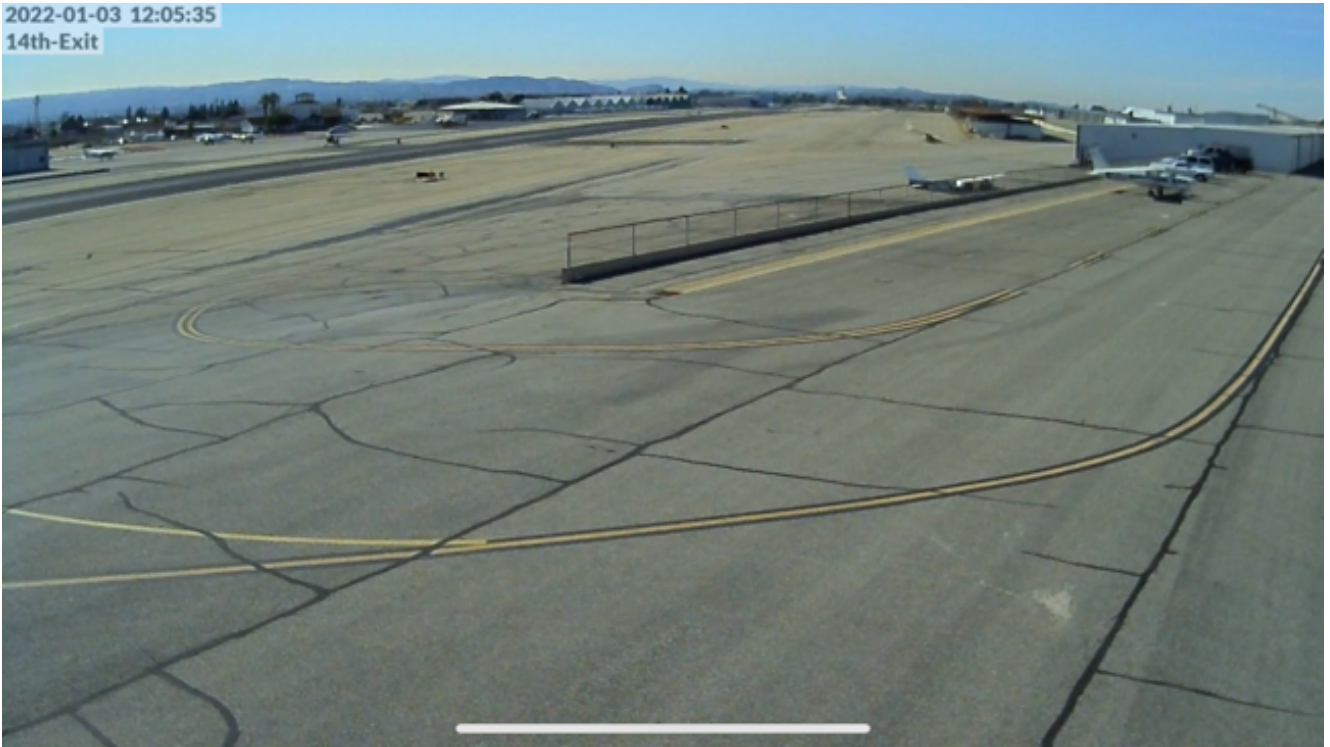
Closer to the open hangars

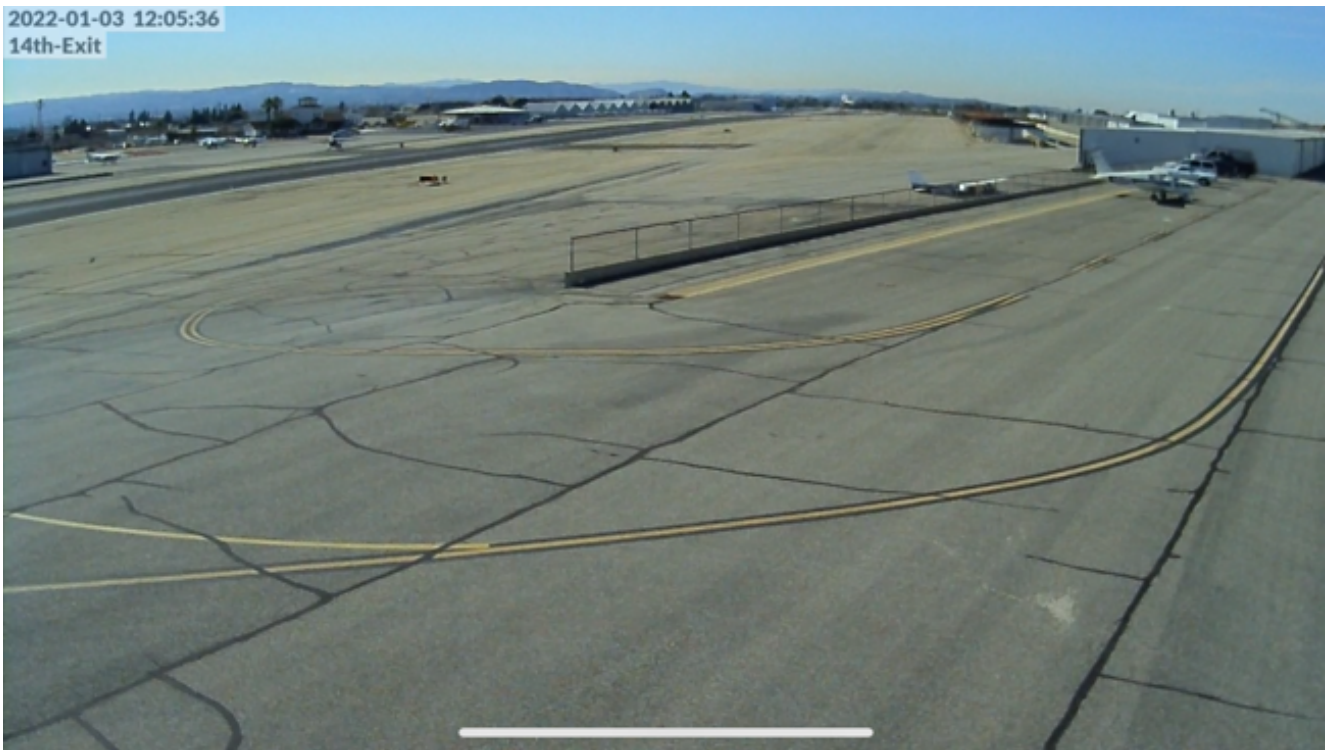
Airplane comes to a complete stop

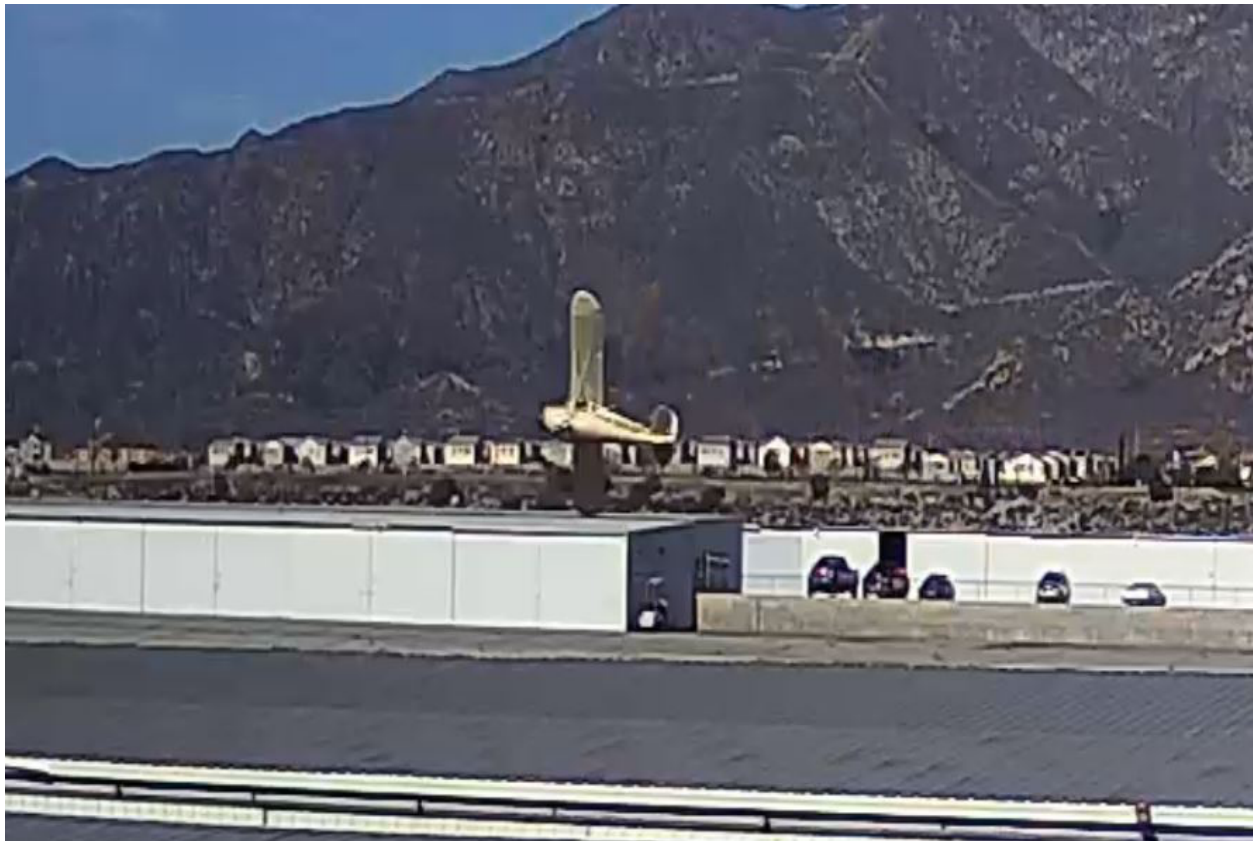
Opposite aileron can be seen here in an attempt to stop the aircraft from rolling.

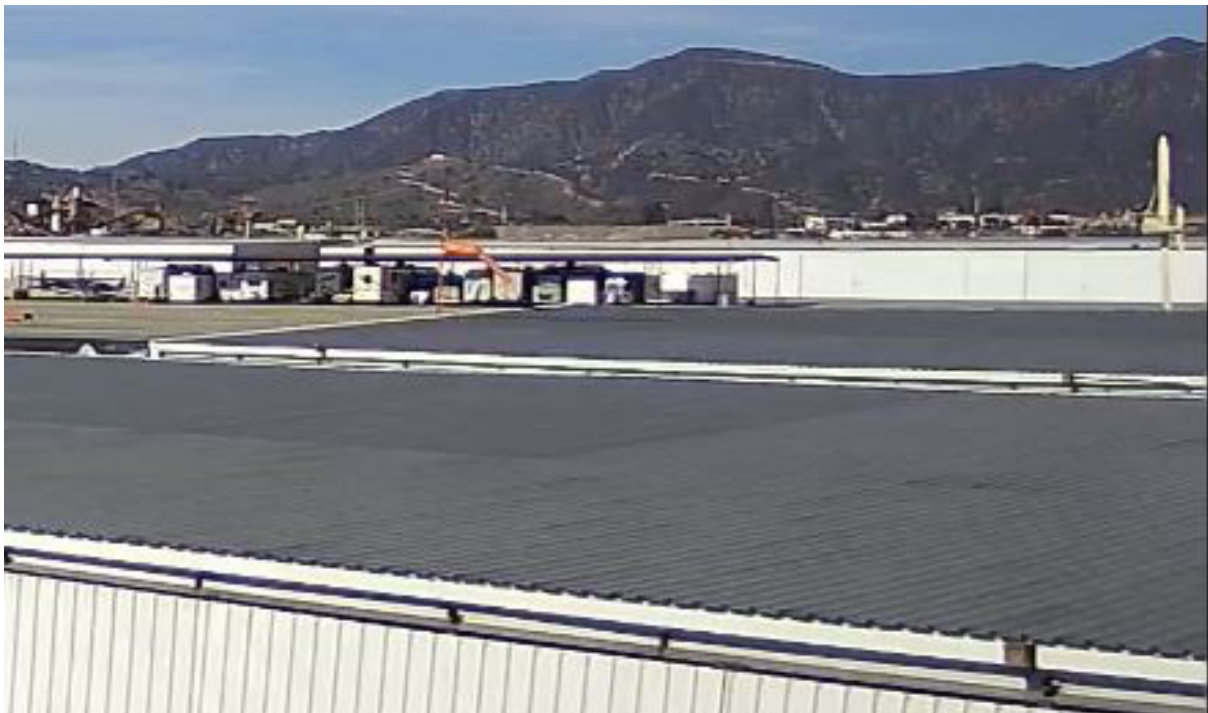
Aircraft Banked 90° to the right seconds prior to impact.
