ACCIDENT

Aircraft Type and Registration:	Piper PA-46-350P (Modified), G-HYZA	
No & Type of Engines:	2 YASA electric motors (common shaft)	
Year of Manufacture:	1997 (Serial no: 4636130)	
Date & Time (UTC):	29 April 2021 at 1425 hrs	
Location:	Near Cranfield Airport, Bedfordshire	
Type of Flight:	Other	
Persons on Board:	Crew - 2	Passengers - None
Injuries:	Crew - None	Passengers - N/A
Nature of Damage:	Left wing detached, landing gear collapsed and nose cowl distortion	
Commander's Licence:	Airline Transport Pilot's Licence	
Commander's Age:	63 years	
Commander's Flying Experience:	34,620 hours (of which 1,588 were on the basic type, 12 were on the modified electric variant) Last 90 days - 59 hours Last 28 days - 19 hours	
Information Source:	AAIB Field Investigation

Synopsis

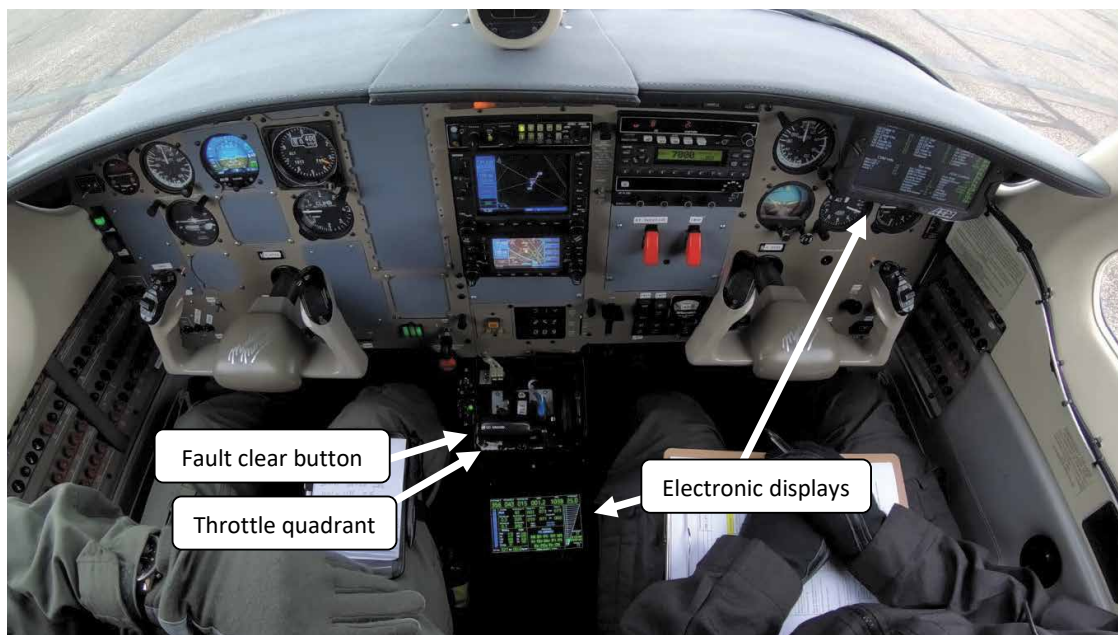
Figure 4

Two display screens were fitted to show the power plant and motor parameters, one was located on the cockpit centre console next to the pilot, and the other on the right side of the cockpit next to the observer's seat (Figure 4). The pilot used the display below the throttle quadrant to adjust power and rpm settings throughout the flight. Of note, when the pilot's hand adjusted the power, it could obscure this display.

The certification basis⁸ of the PA-46 contains requirements for the design of electronic displays that represent good practice within aviation. As an E Conditions aircraft, G-HYZA was not required to comply with these standards; however, CAP1220 refers to guidance in CAP659⁹ 'A guide to Approval, Construction and Operation of Amateur Built Aircraft'. To assist those undertaking projects, Appendix 1 of this document sets out the design criteria for different types and weights of aircraft. The weight of G-HYZA would place it under Certification Standard (CS) 23, which includes a section on instruments and displays.

It is recommended that the Civil Aviation Authority develops guidance in CAP1220, Operation of Aircraft Under E Conditions, regarding the use of existing guidance on the design and positioning of controls and displays used in the operation of the aircraft.

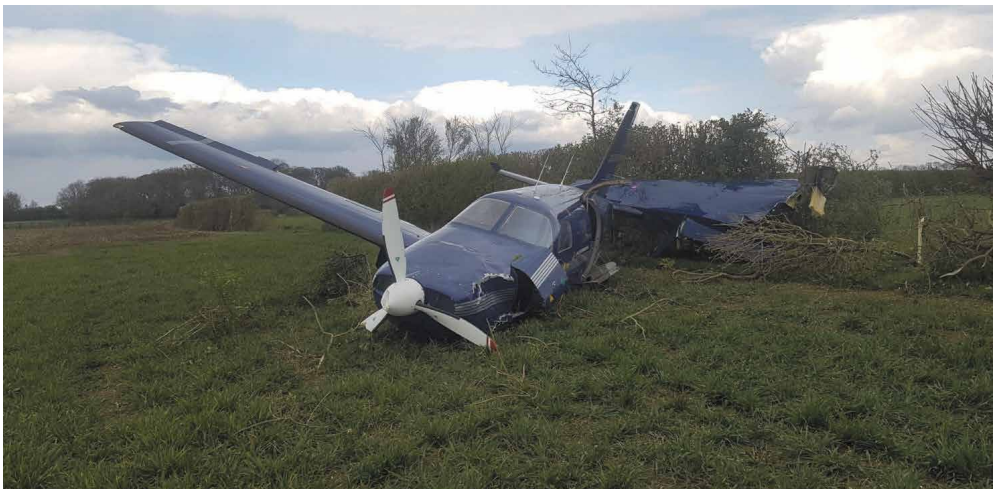
Figure 6
G-HYZA accident site

The aircraft landed in a field which was 210 m wide, approximately 445 m in length, corner to corner, and bounded by a road and hedges. It touched down approximately one third along the length of the field and after 290 m struck a hedge where the left wing detached from the fuselage and the nose landing gear collapsed. The propeller, nose cowling and tailplane were also damaged (Figure 6). The aircraft remained upright, leaning to its left side sufficient to prevent the lower step section of the cabin door from fully opening. There was no fire.

- The nose landing gear had been forced upwards into the nose area and caused bending and displacement of the motor and HFC mounting frame by approximately 25 mm.
- The nose structure showed no other damage except for the pulling through of a fastener holding the coolant header tank, which was still attached and free from leakage. All the other components remained attached and in place with the mounting frame displacement being taken up by the flexing of the wiring and non-rigid pipework.
- The HV battery contactor box, also located in the nose area, was crushed such that the insulation within the cover was touching the top of some of the contactor terminals.
- There was no evidence of leakage from the motor cooling oil and inverter / HFC cooling systems.

- The hydrogen storage tanks, regulator and distribution systems were visually undamaged and there was no leakage. This was confirmed by the fact that the hydrogen detectors did not trigger.
- The cabin mounting structure for the hydrogen storage tanks and HV battery showed no signs of movement or damage, and all the attached items were retained in their original position.
- The egress path between the cockpit and the cabin exit door remained clear.

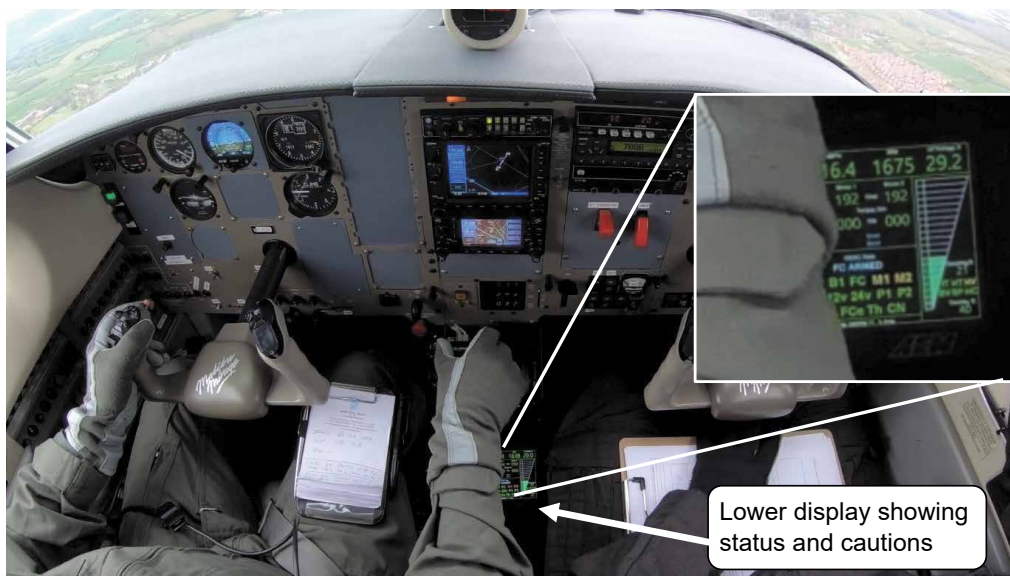
Figure 10
G-HYZA cockpit camera view, just after HV selected OFF,
showing zoom of lower display

The on-board camera showed that immediately after the HV battery was selected OFF, the displays showed M1 and M2 initially in red, then amber, representing motor fault conditions. Four seconds later, the pilot noted the loss of power. Five seconds after this, the observer stated, "YOU'VE LOST THE INVERTER, PUSH THE BUTTON".

The pilot pushed the fault clear button with the recorded power lever position still at 41%. This successfully reset the inverter; however, as the power lever was not at idle, the step demand for power after the reset could not be provided by the HFC leading to a voltage drop. This was detected by the inverter as an undervoltage and caused an additional lockout.

The observer instructed the pilot to select HV battery ON which was successful. However, due to the combination of an increased HFC voltage and continued windmilling action of the propeller, the inverters detected further overvoltage conditions which led to further lockouts. After HV battery was selected ON, further attempts were made to restore power over the next 38 seconds with the observer acknowledging that "THE VOLTAGE IS TOO HIGH". This included resetting the HFC and HV battery supplies with the fault clear button selection at various power lever positions, with no visual reference to checklists. The troubleshooting required the pilot to look down to the power lever and display and then look up to the HFC and HV battery switches in the overhead panel. Despite these attempts, power could not be restored to the motors. Figure 11 shows these data parameters throughout the event.

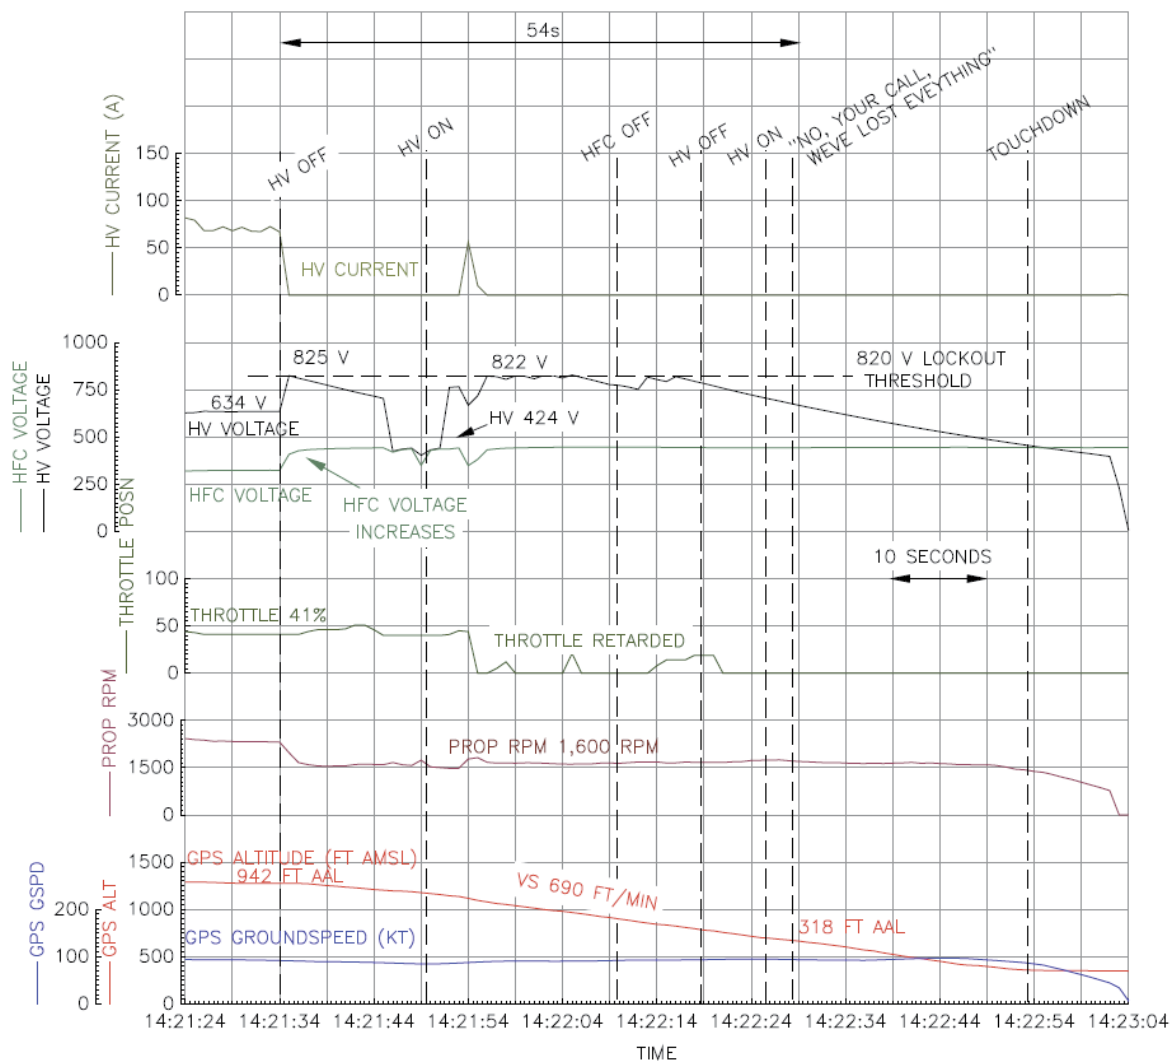
Figure 11
G-HYZA flight data parameters

When the HV battery was switched off, the sequencing of the contactors, to allow the HFC alone to provide electrical power, resulted in a momentary interruption of the power supply to the motors. During this brief period the propeller was driven by the airflow which caused the motor to act as a generator. The resulting voltage was high enough to cause the inverter overvoltage protection to lockout the power supply to the motors.
