Aviation Investigation Preliminary Report

Location:	Queens, NY	Incident Number:	DCA23LA125
Date & Time:	January 13, 2023, 20:44 Local	Registration:	N914DU (A1); N754AN (A2)
Aircraft:	Boeing 737-900ER (A1); Boeing 777-223 (A2)	Injuries:	159 None (A1); 149 None (A2)
Flight Conducted Under:	Part 121: Air carrier - Scheduled (A1); Part 121: Air carrier - Scheduled (A2)

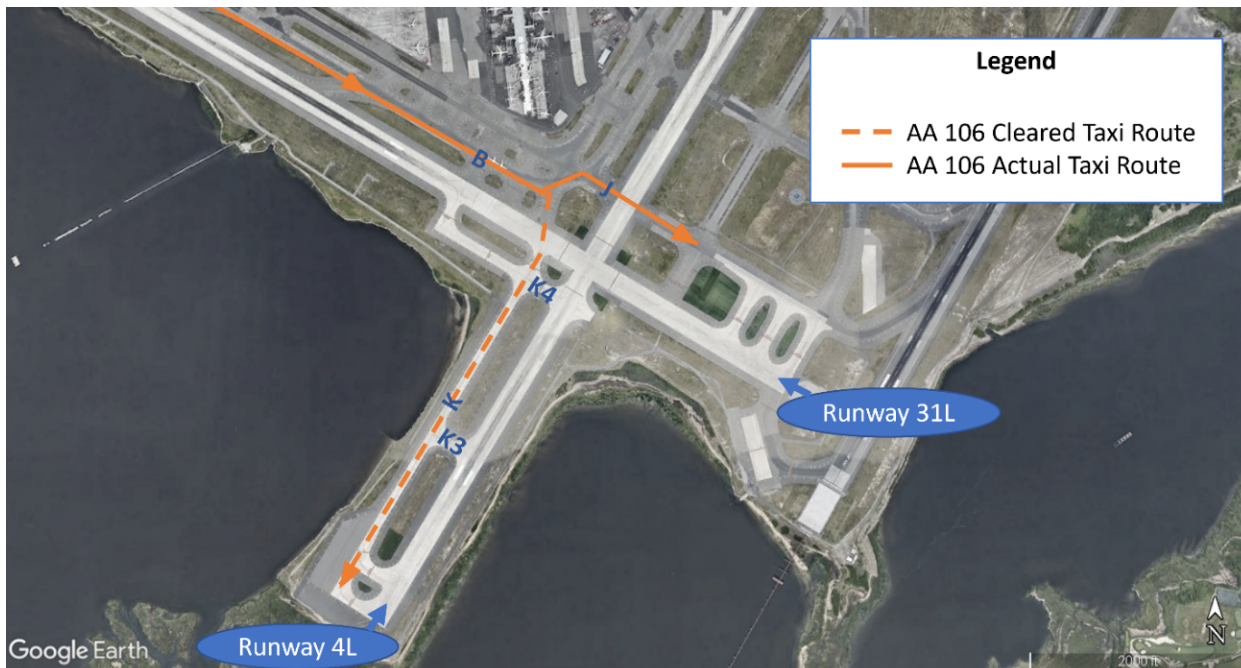
AA 106 was instructed to taxi from the ramp to Runway 4L via taxiway B and hold short of taxiway K. As the aircraft left the ramp, the ground controller cleared AA 106 to cross runway 31L at taxiway K. Upon reaching the Taxiway B/Taxiway K intersection, AA 106 continued straight to taxiway J crossing runway 4L without ATC clearance. At the time AA106 entered on runway 4L at taxiway J, DAL 1943 had begun its takeoff roll increasing speed through 80 knots, and was abeam taxiway K3, about 2700 feet from the taxiway J intersection.

Figure 1. Depiction of AA106 cleared vs. actual taxi route (adapted from Google Earth)

The ASDE-X alerted the JFK ATC tower to the conflict and the tower controller issued a takeoff cancellation to DAL 1943. The DAL 1943 crew aborted takeoff at about 100 knots and came to stop about 500 feet short of taxiway J. The closest point between the two aircraft was about 1400 feet and occurred as DAL 1943 decelerated past taxiway K4 and AA106 exited the runway at taxiway J.
