Aviation Investigation Final Report

Location:	Kahului, Hawaii	Incident Number:	DCA23LA172
Date & Time:	December 18, 2022, 14:51 Local	Registration:	N212UA
Aircraft:	Boeing 777	Aircraft Damage:	None
Defining Event:	Altitude deviation	Injuries:	281 None
Flight Conducted Under:	Part 121: Air carrier - Scheduled

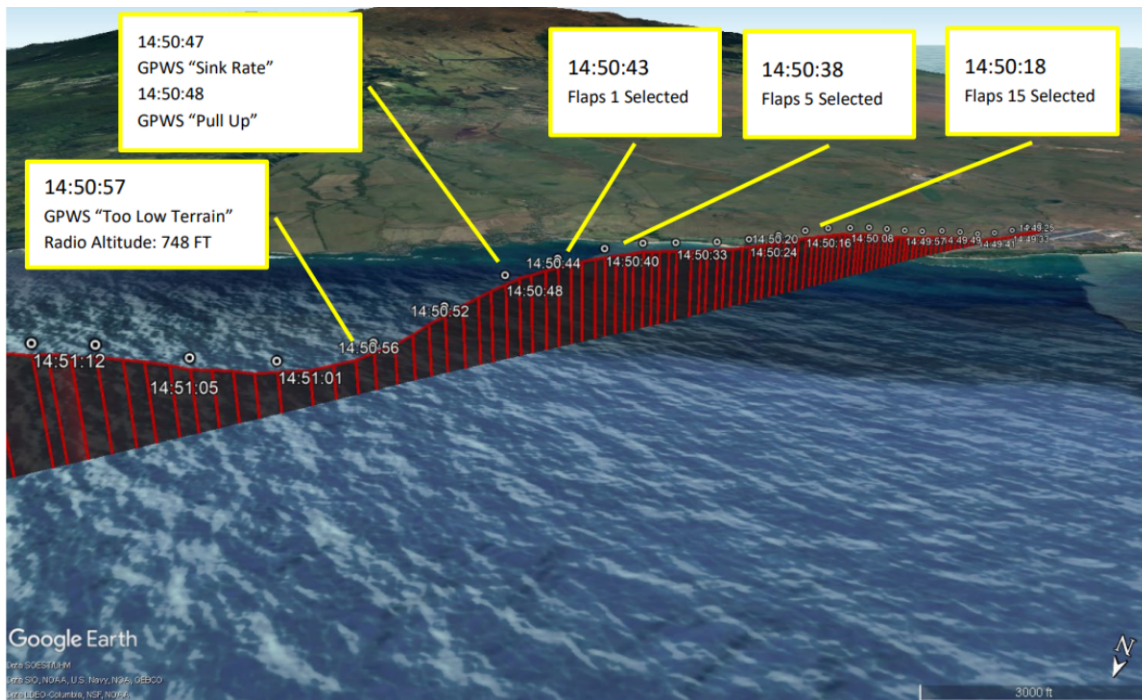
United flight 1722 lost altitude about 1 minute after departure while in instrument meteorological conditions, which included heavy rain. The airplane descended from 2,100 ft to about 748 ft above the water before the crew recovered from the descent. No injuries were reported, and the airplane was not damaged. The NTSB was not originally notified of the event, since it did not meet the requirements of Title 49 *Code of Federal Regulations* Part 830.5. However, the NTSB learned of the event about 2 months later and chose to open an investigation. By that time, both the cockpit voice and flight data recorder durations had been exceeded. The investigation utilized flight crew statements and other records as information sources.

Both pilots recalled hearing the initial warnings from the ground proximity warning system (GPWS), and the first officer recalled announcing “pull up pull up” along with those initial GPWS warnings. The captain then pulled aft on the control column, initially reduced power to reduce airspeed, and then applied full power to “begin the full CFIT [controlled flight into terrain] recovery.” The first officer recalled that, as the captain was performing the recovery, the GPWS alerted again as the descent began to reverse trend; data showed this occurred about 748 ft above the water. After noting a positive rate of climb, the captain lowered the nose to resume a normal profile, ensured that the flaps and speed brakes were fully retracted, and engaged the autopilot. The remainder of the flight was uneventful.

Figure 1 shows a perspective view of the flight track.

As a result of the event, United Airlines modified one of their operations training modules to address this occurrence and issued an awareness campaign about flight path management at their training center.
