Aviation Investigation Final Report

Location:	Truckee, California	Accident Number:	WPR21FA286
Date & Time:	July 26, 2021, 13:18 Local	Registration:	N605TR
Aircraft:	BOMBARDIER INC CL-600-2B16	Aircraft Damage:	Destroyed
Defining Event:	Loss of control in flight	Injuries:	6 Fatal
Flight Conducted Under:	Part 91: General aviation - Personal

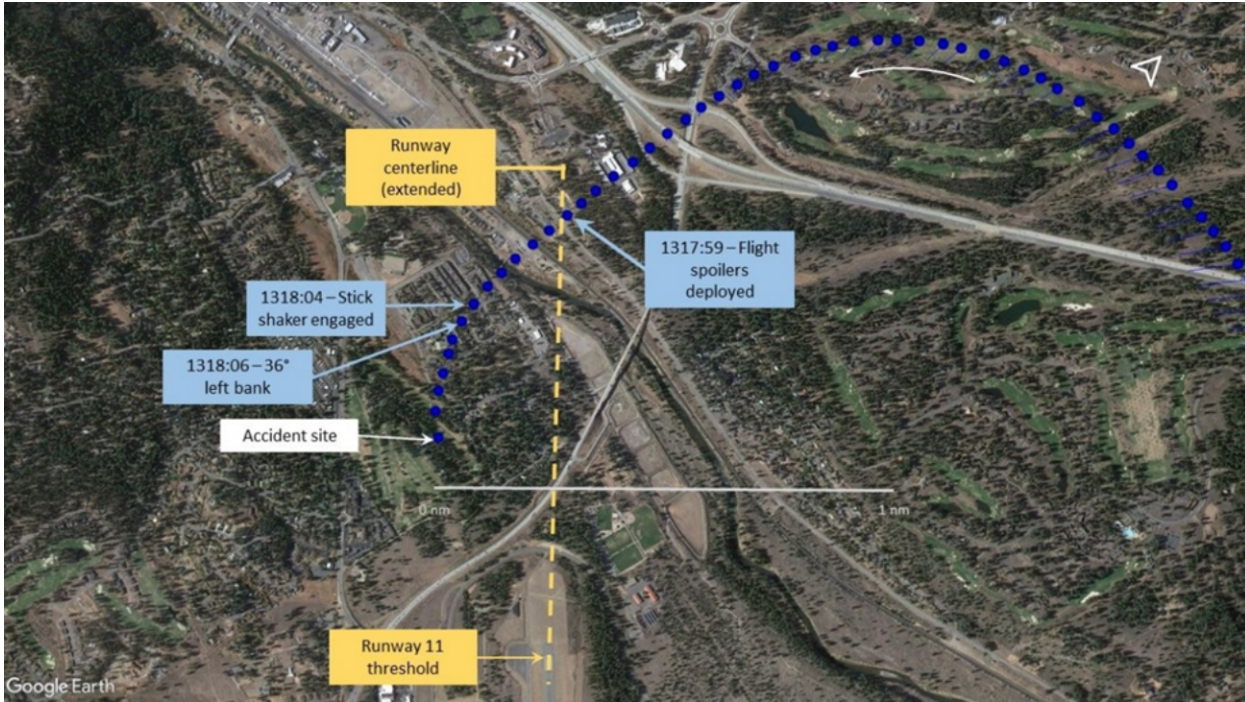
At 1317:59, the airplane began a left turn that reached a bank angle of 36° about 4 seconds later. According to the CVR data, the stick shaker engaged at 1318:04, then the captain asked, “What are you doing,” which was followed by a stall warning sound. The airplane was on a south heading about 0.75 nm from the runway threshold as it continued to turn back toward the extended runway centerline (see figure 3). The stick pusher engaged about 1318:05. (For more information about the stick shaker and stick pusher, see the section below about the SPS.) The captain again asked the FO, “What are you doing?” and the FO then asked the captain three times over 2 seconds to “let me have the airplane.” The stick pusher disengaged at 1318:07 followed immediately by the stick shaker disengaging. At 1318:09, the stick shaker engaged again followed immediately by the stick pusher engaging, and the airplane was about 6,075 ft msl on a southeasterly heading when it entered a rapid left roll. The airplane was in a 111° left-wing-low bank angle at 1318:11 and 1 second later it was in a 146° right-wing-low bank angle and an approximate 30° nose-low attitude, just before the airplane impacted terrain and a postcrash fire ensued.

Figure 3. Accident airplane's flightpath during final approach after crossing the runway centerline.
