SAIB: 2024-02
Date: April 4, 2024

SUBJ: Wing Spar

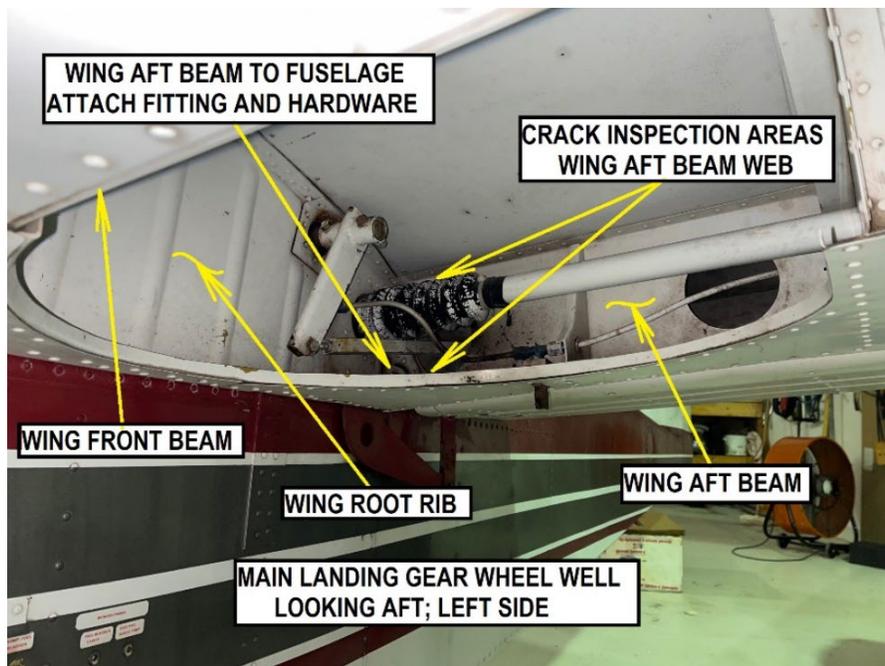
Figure 1
Lake LA-4-200 Buccaneer MLG Wheel Well

Figure 1 shows a Lake LA4-200 Buccaneer looking aft into the left-hand main landing gear (MLG) wheel well and shows the area where cracks are occurring and the recommended inspection area. Figure 1 also shows the inspection area and the accessibility to perform the recommended inspections.

2. Inspect all wing attach fittings for security, wear, corrosion, damage, and condition of sealant at fuselage.
3. Inspect wing aft beam assembly for damage, distortion, corrosion, and general condition. Perform close visual inspection around the lightning holes near the large cut out in the aft web. Look for indications of cracking as shown in the pictures above.

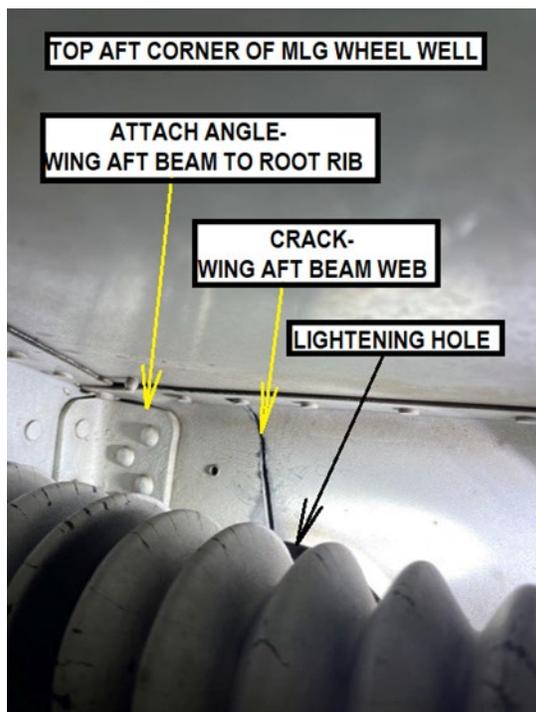
Figure 2

Figures 2 and 3 show cracks found on a Lake LA-4-200 Buccaneer Left side rear attach beam assembly. The small holes shown in the web are manufacturer holes presumably for part positioning during forming processes.

Lake LA-4-200 Buccaneer MLG Wheel Well
Top Aft Corner (Left Side Looking Aft)

6. If cracks, gaps, or elongated holes are found, repair or replace parts in accordance with the manufacturer's instructions, or using other methods, techniques, and practices acceptable to the Administrator provided in FAA Advisory Circular [AC 43.13-1B](#)

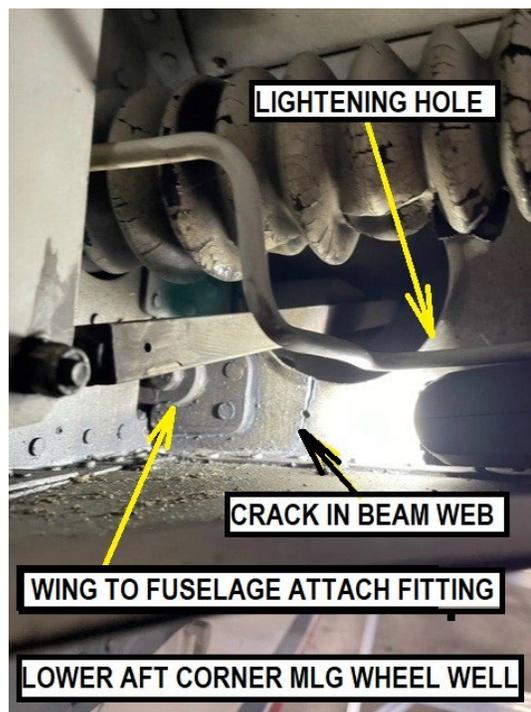
Figure 3

Lake LA-4-200 Buccaneer MLG Wheel Well
Bottom Aft Corner (Left Side Looking Aft)
