# Aviation Investigation Final Report

| <b>Location:</b> | St. Mary's, Alaska | <b>Accident Number:</b> | ANC23FA074 |
| <b>Date &amp; Time:</b> | September 12, 2023, 20:47 Local | <b>Registration:</b> | N109T |
| <b>Aircraft:</b> | Piper PA-18-150 | <b>Aircraft Damage:</b> | Substantial |

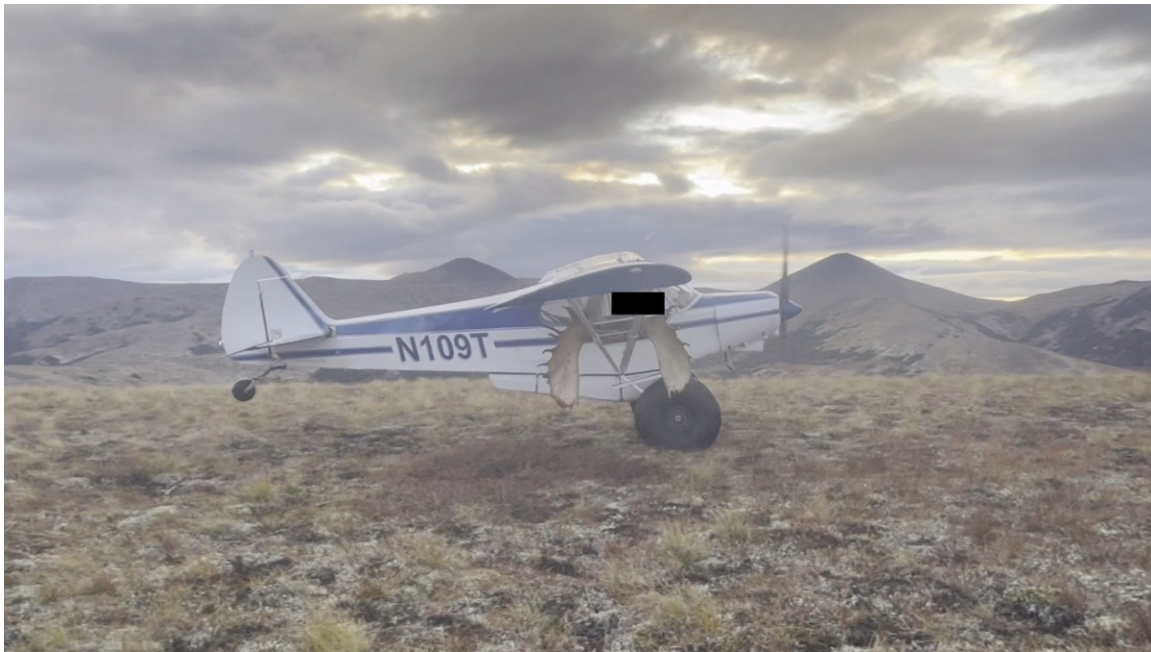
One of the hunters recorded a video of the takeoff. The video showed that the airplane began the ground roll at the southern end of the airstrip and departed uphill to the north. The flaps were retracted, and the tail of the airplane came up as soon as the pilot applied engine power (see figure 1). The ground roll lasted about 530 ft, and immediately after takeoff, the airplane pitched up and rolled right (see figure 2). The airplane then rolled to a wings-level attitude, and the video ended a few seconds later. The engine was heard operating during the recording and the airplane was not trailing smoke or vapor.

Figure 1. Airplane during the takeoff roll (Source: hunter video).

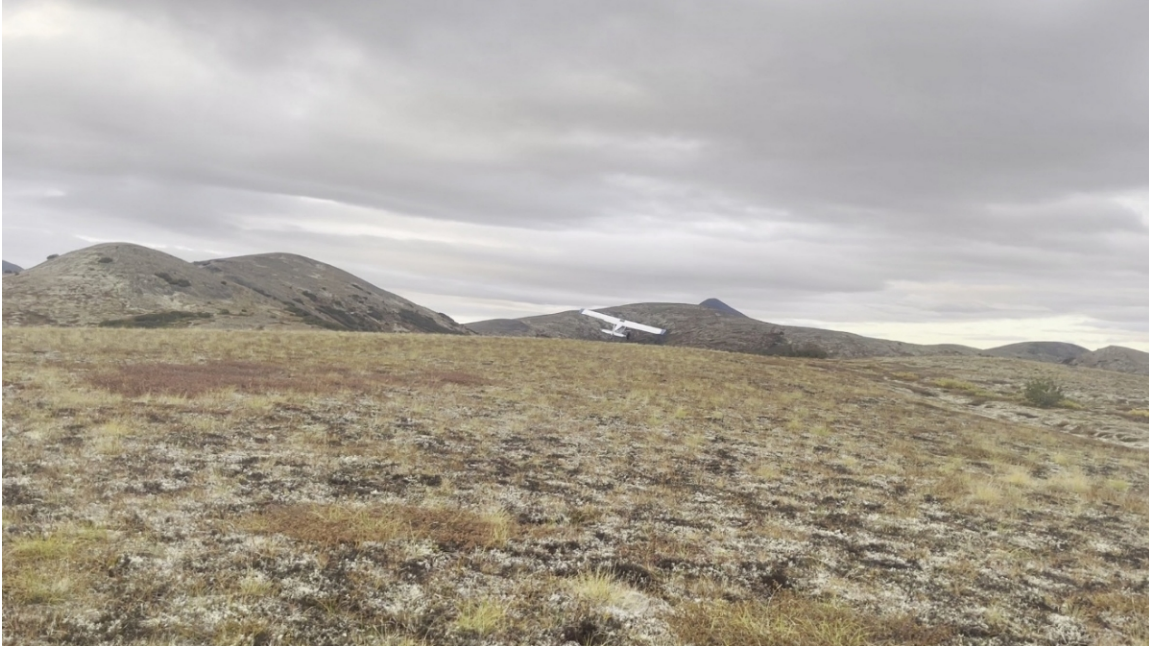
Figure 2 - Airplane rolling right immediately after takeoff (Source: hunter video).

Analysis revealed that the estimated pitch angle during takeoff was about 16.2°, and the right bank angle after rotation was 16.6°. The bottom of the cargo pod that was mounted under the fuselage sloped up by 13° toward the tail of the airplane when the airplane pitch angle was zero. Therefore, at the highest airplane pitch angle, the bottom of the cargo pod sloped down toward the tail by 3.2°, with an uncertainty of  $\pm 1.5^\circ$ .

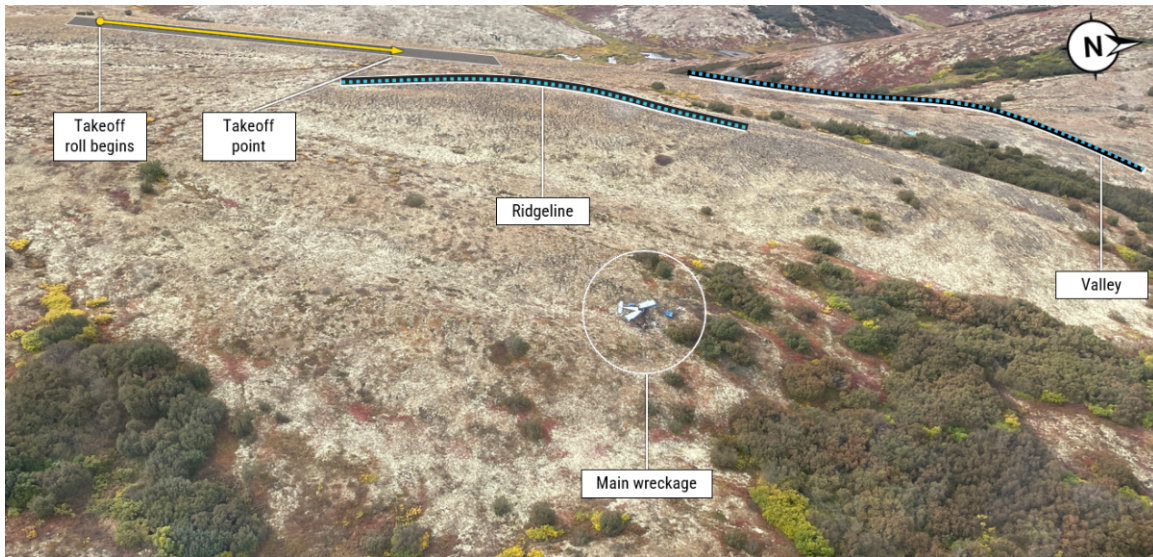
The airplane came to rest on a 30° downward slope on the other side of the adjoining ridgeline, at an elevation of 1,210 ft mean sea level, about 10 ft lower and 600 ft east of the departure end of the airstrip (see figure 3). The surrounding area consisted of rolling hills covered in tundra, grass, and low-lying shrubs and bushes.

Figure 3 - Accident site.

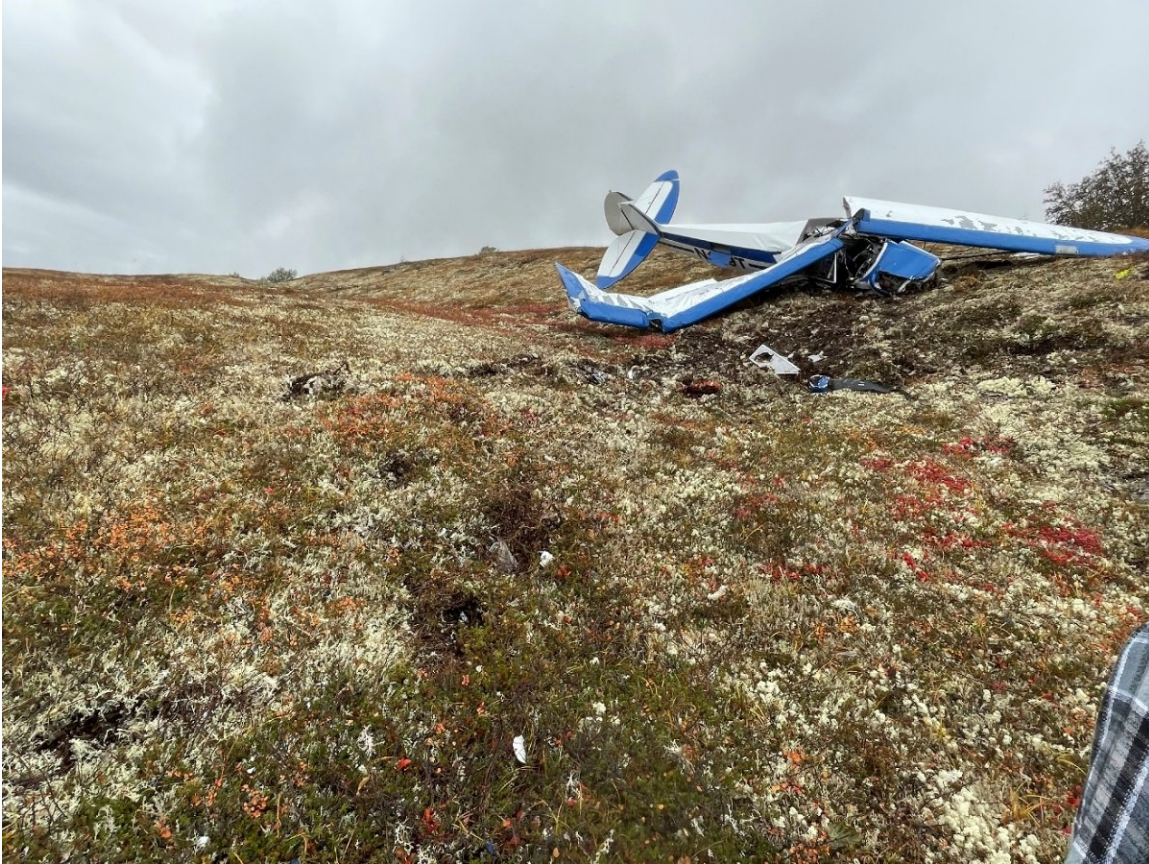
The fuselage came to rest on a northerly heading, and both wings remained partially attached and generally in line with each other on a northwest-southeast orientation. The first identified point of impact was located about 20 ft below the main wreckage, and consisted of a divot in the soil that contained blue and white fragments that matched the right wingtip (see figure 4). The right wing landing light assembly and right window frame were located about 5 ft uphill in a westerly direction. A large divot in the soil, which was located 5 ft farther uphill, matched the general dimensions of a main landing gear tire. Adjacent to this hole was the propeller, which had separated from the crankshaft.

Figure 4 - Accident site with the first point of impact in the foreground.
