Aviation Investigation Preliminary Report

Location:	San Diego, CA	Accident Number:	WPR25FA169
Date & Time:	June 8, 2025, 12:30 Local	Registration:	N414BA
Aircraft:	Cessna 414	Injuries:	6 Fatal
Flight Conducted Under:	Part 91: General aviation - Business

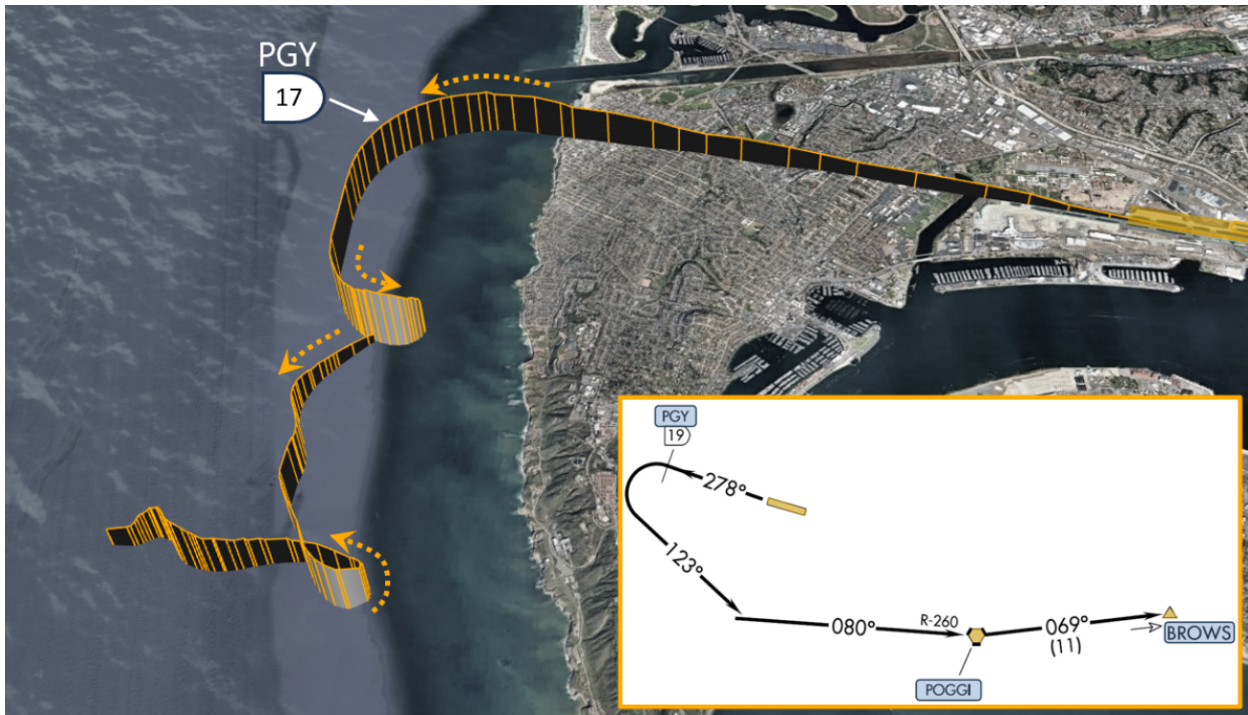
After departing from runway 27, the pilot made a radio communication to SOCAL departure that he was at 1,600 ft, and shortly thereafter, the controller instructed him to make a left, 180° turn. The airplane began a gradual turn, and after climbing to about 2,000 ft, it made a steep descent to 200 ft. The controller issued the pilot a low altitude alert and instructed him to climb to 4,000 ft immediately to which the pilot replied by repeating the instructions. The controller then asked if he needed any assistance and queried him as to the nature of the problem. The pilot stated that he was “struggling” to try to maintain the airplane on a heading and climb. In response, the controller told him of the closest airport that was one mile away and asked him if he could see it. The pilot responded that he did not see the airport and made a series of erratic maneuvers before making several mayday calls (see figure 1 below).

Figure 1: Airplane's flight path with the pictorial approach procedure

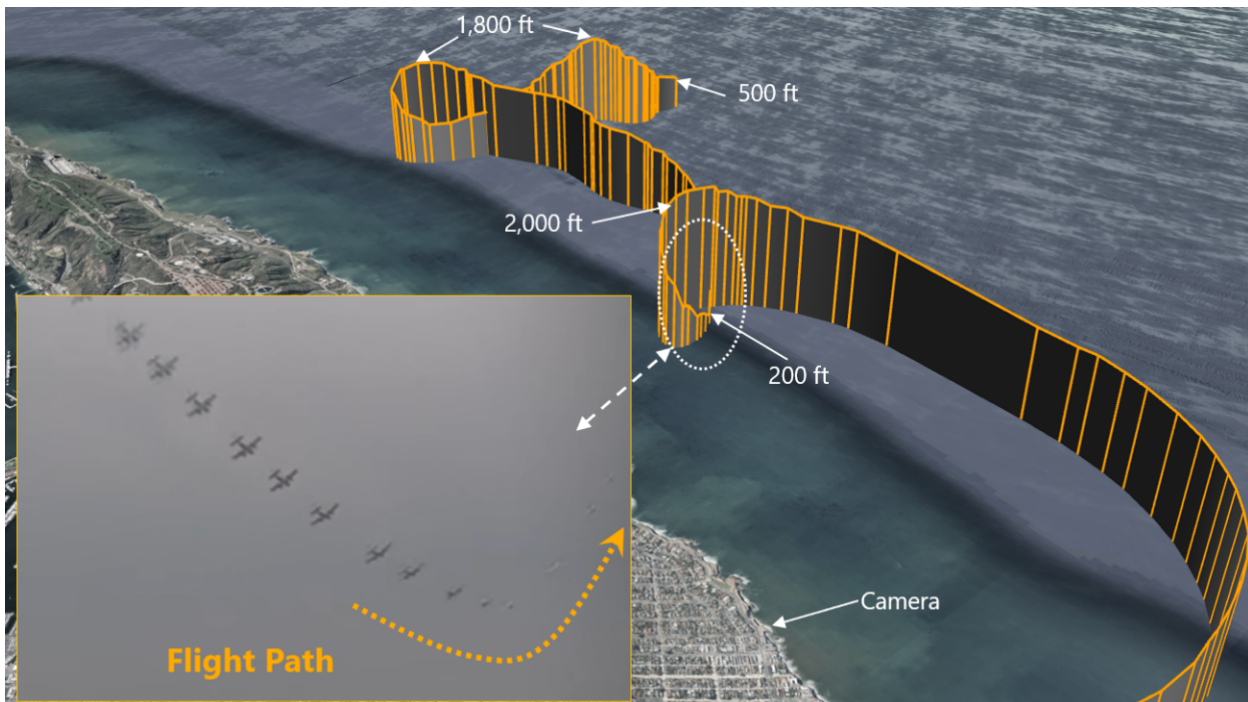
A video captured the airplane descending before climbing back into the cloud layer, where it subsequently disappeared from view (see figure 2 below).

Figure 2: Flight path and composite video graphic showing the airplane climbing into the cloud layer
