# Aviation Investigation Preliminary Report

| <b>Location:</b> | Statesville, NC | <b>Accident Number:</b> | WPR26MA063 |
| <b>Date &amp; Time:</b> | December 18, 2025, 10:22 Local | <b>Registration:</b> | N257BW |
| <b>Aircraft:</b> | Cessna 550 | <b>Injuries:</b> | 7 Fatal |

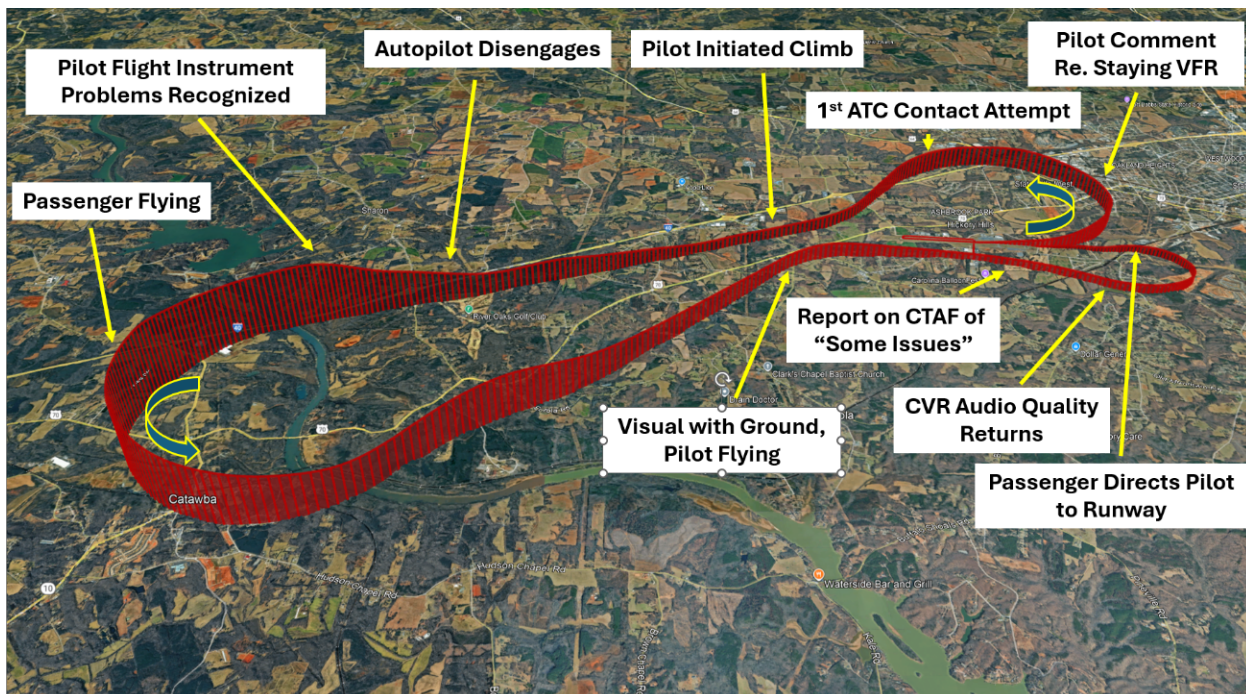
Figure 1: Flight Path Overview with Sequence of Events

Recorded data from the GTN-750 showed that the airplane’s airspeed and altitude continued to decrease from the time the airplane was aligned on final approach to the runway until 1015:18, when the airplane was at 984 ft msl and 99 kts IAS. The airplane continued to descend to 942 ft msl until the CVR audio and GPS data ended at 1015:23. The IAS increased to 107 kts and then decreased to about 93 kts during the final five seconds of data. (See figure 1.)

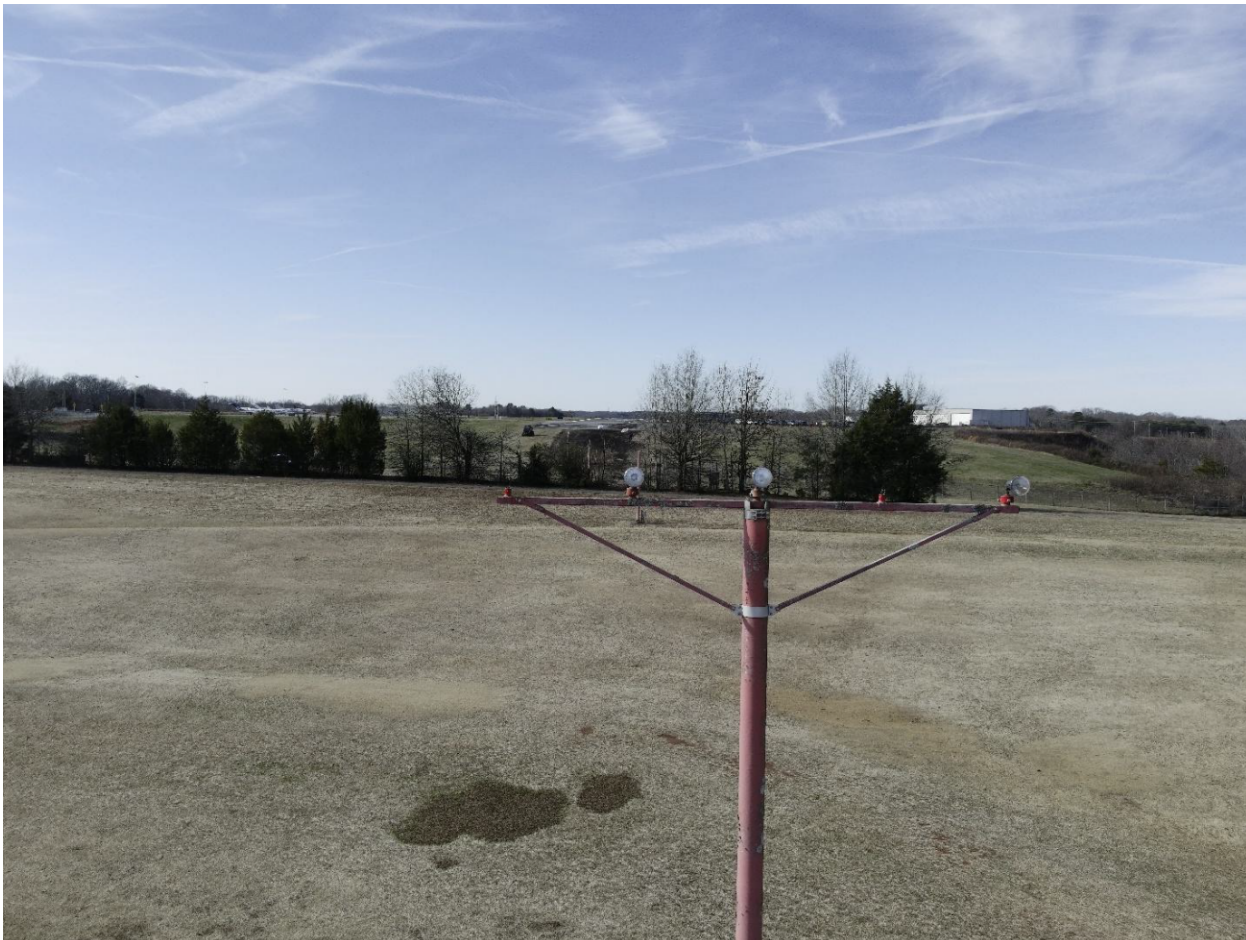
Figure 2: First Identified Point of Impact

Examination of the accident site revealed that the first identified point of impact (FIPI) was the first (easternmost) light station of the runway 28 Medium Intensity Approach Light System with Runway Alignment Indicator Lights (MALSR), located about 1,380 ft from the runway threshold. Two lightbulbs, the left and fourth from the left position (when viewed looking towards the runway), approximately 6 ft apart, were separated from the otherwise intact 29 ft tall light station (figure 2) and located on the ground near the station. The upper portion of the second MALSR light station located about 180 ft from the FIPI was separated, of which about 15 ft of the frangible pole was still standing. A group of damaged trees located about 235 ft from the FIPI, were sheared about 12 ft above ground level (agl). The first indication of fire was blackened branches and grass near the west side of the trees.

A ground impression was observed about 350 ft from the FIPI, near the airport perimeter fence, and extended through the MALSR decision light station. The debris path continued along a westerly heading through the runway overrun to where the main wreckage came to rest on the runway blast area about 400 ft short of the runway 28 threshold, oriented on an easterly heading. Heavy charring of the ground began near the decision light station and continued along the remaining length of the debris field to the wreckage.

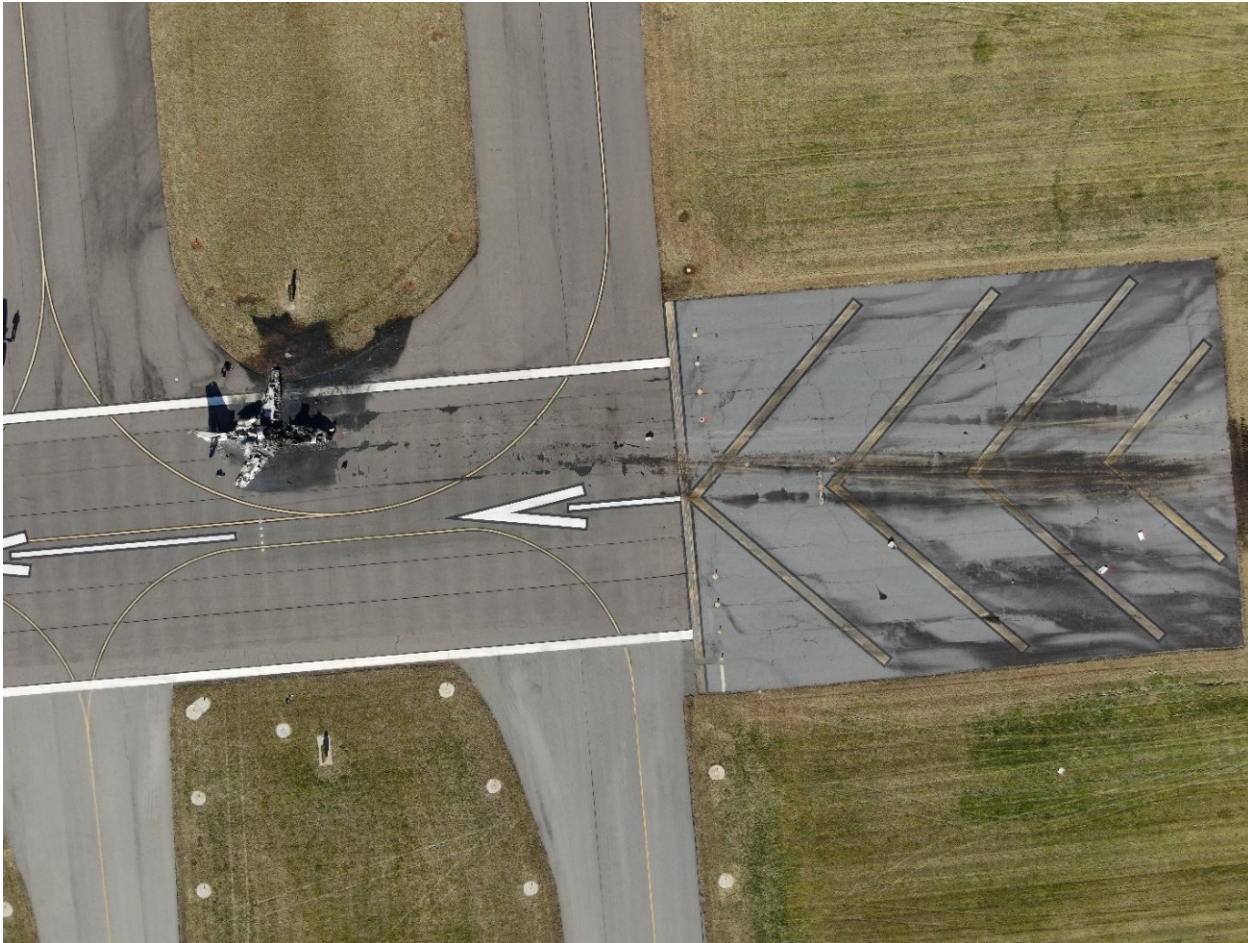
Figure 3: Aerial view of the accident site.

A post impact fire consumed a majority of the fuselage and heat damaged both wings, empennage, and both engines (figure 3). All flight control surfaces were identified in the debris path and main wreckage. No evidence of pre-impact separation of any airplane component or structure was observed.
