# Aviation Investigation Preliminary Report

| <b>Location:</b> | Flagstaff, AZ | <b>Accident Number:</b> | WPR26FA098 |
| <b>Date &amp; Time:</b> | February 4, 2026, 22:16 Local | <b>Registration:</b> | N56AZ |
| <b>Aircraft:</b> | Bell 407 | <b>Injuries:</b> | 2 Fatal |

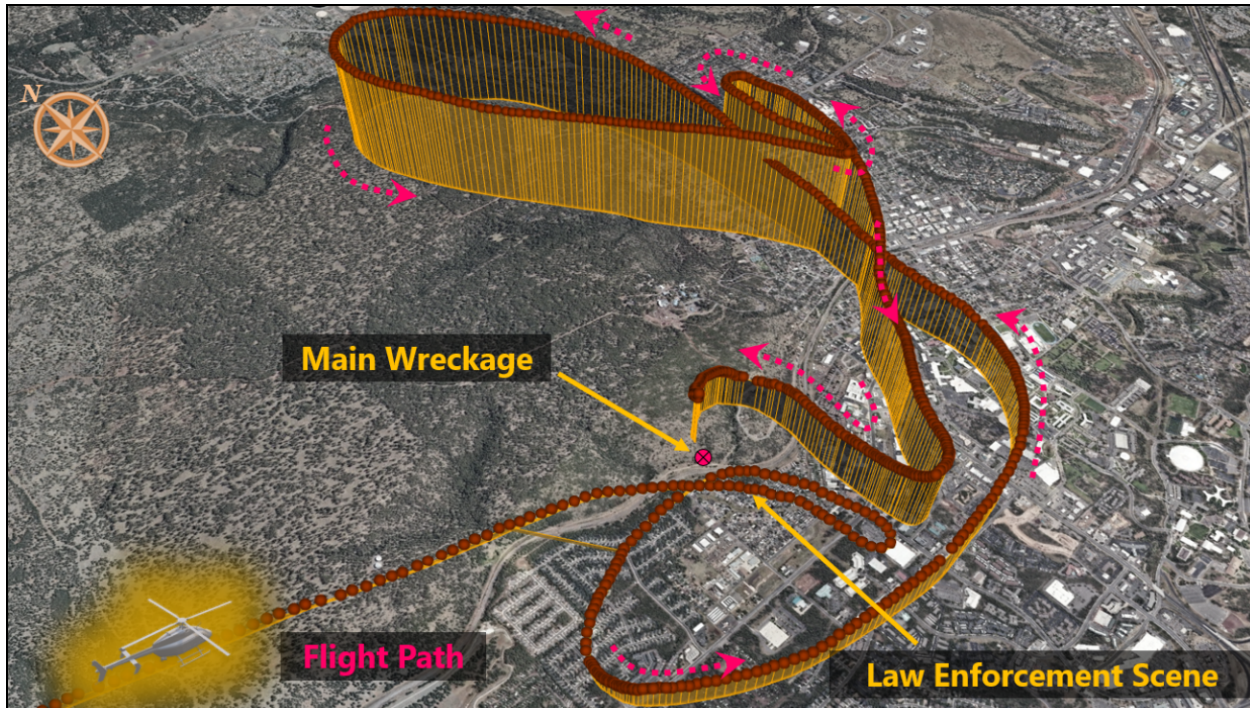
Figure 1: The helicopter's flight path

A review of Federal Aviation Administration (FAA) automatic dependent surveillance-broadcast (ADS-B) data, video and audio recorded by law enforcement body cameras, and residents' security cameras revealed that the helicopter departed Kingman about 2110 and continued east toward Flagstaff. As the helicopter approached the city, the TFO was in communication with law enforcement personnel on the ground, who provided the approximate location of the active shooter. At 2205, the helicopter descended and operated between about 300 and 500 ft agl while performing a 360° turn over the neighborhood in the vicinity of the active shooter. The helicopter then performed a gradual climbing left turn south of the active shooter before establishing a northerly course. (See figure 1.)

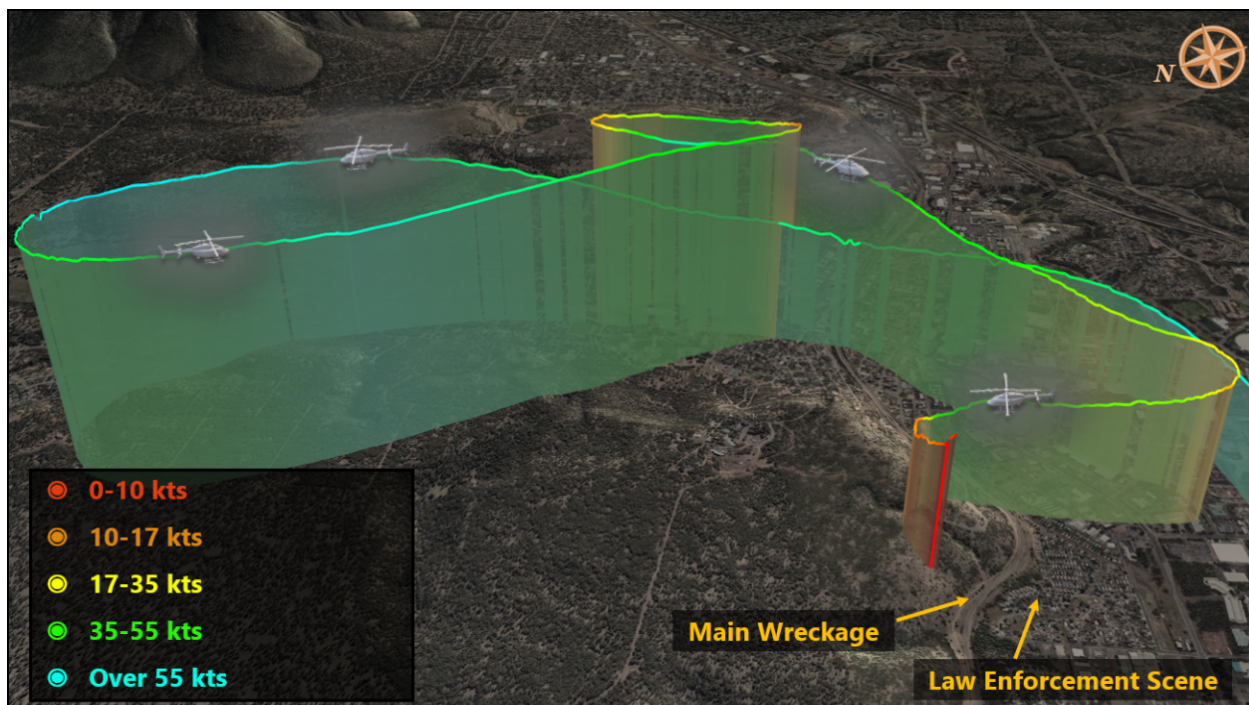
Figure 2: Flight path displaying airspeeds

The pilot maneuvered the helicopter in a gradual climb north of the neighborhood and performed a left 180° turn to return south to allow clearance for a helicopter that was inbound to Flagstaff Medical Center. At 2212:10, while the helicopter was at an altitude of 9,950 ft msl, it passed in the vicinity of the hospital-bound helicopter, which was on a northeast route at about 7,200 ft msl. Thereafter, the helicopter performed a left 360° turn and returned south toward the law-enforcement scene while descending to 8,900 ft msl (see figure 2 below). The helicopter then turned north and performed a gradual climbing left turn, consistent with aligning for an out-of-ground-effect (OGE) hover to maintain visual contact of the suspect. At 2216:24, the TFO initiated a radio transmission to law enforcement personnel on the ground; there were no indications of any abnormalities during the communication.

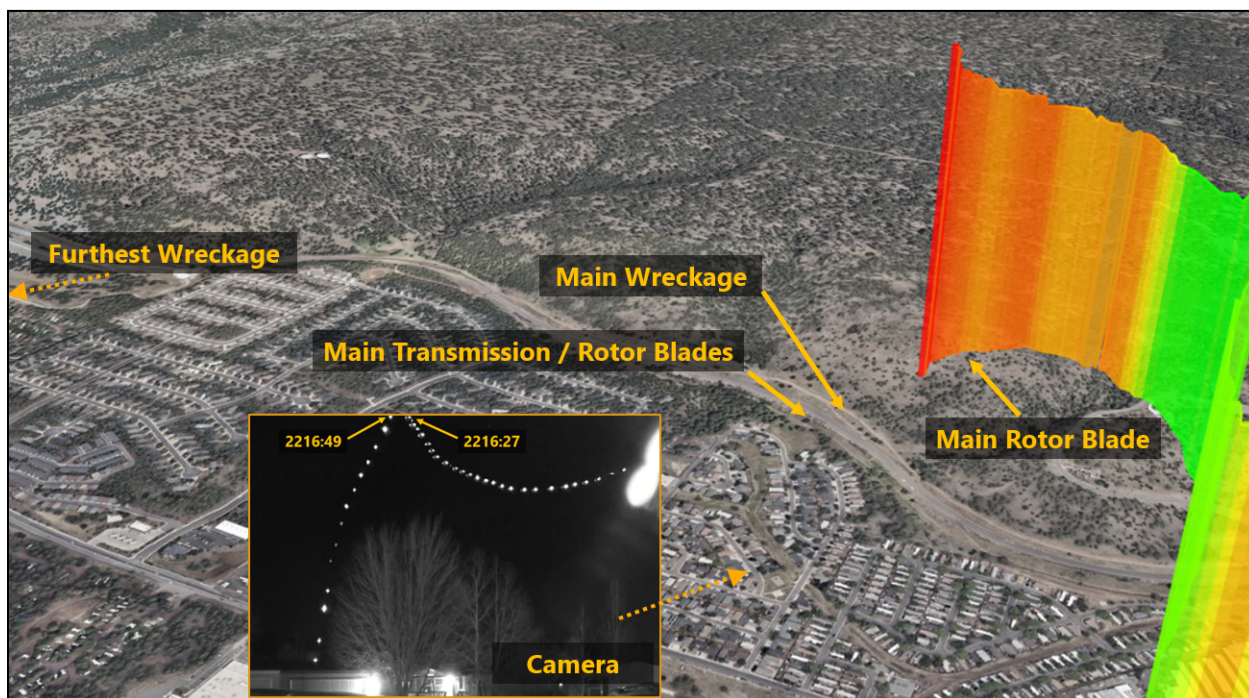
Figure 3: Picture of wreckage distribution and composite of video

A review of available video showed the helicopter in a slow climb and then at 2216:43, the helicopter began a rapid rotation to the right. The rotation coincided with an unidentified verbal sound on the radio, followed by two loud banging sounds from the helicopter. The helicopter then descended rapidly toward terrain and at 2216:51, the TFO stated over the radio, “we’re going down.” During the descent, the helicopter’s spotlight was observed in video to flash periodically, consistent with continued aircraft rotation.

The main rotor hub, main rotor transmission, and three main rotor blades were located about 165 ft south of the main wreckage (see figure 3 below). The fourth main rotor blade, blade grip, and portion of its respective yoke were not located with the main rotor assembly; it was separated from the rotor hub and located 650 ft northeast of the main wreckage. All blades were lightly coated with an orange/yellow oil film.
