# Aviation Investigation Final Report

| <b>Location:</b> | Naples, Florida | <b>Accident Number:</b> | ERA24FA110 |
| <b>Date &amp; Time:</b> | February 9, 2024, 15:11 Local | <b>Registration:</b> | N823KD |
| <b>Aircraft:</b> | BOMBARDIER INC CL-600-2B16 | <b>Aircraft Damage:</b> | Destroyed |

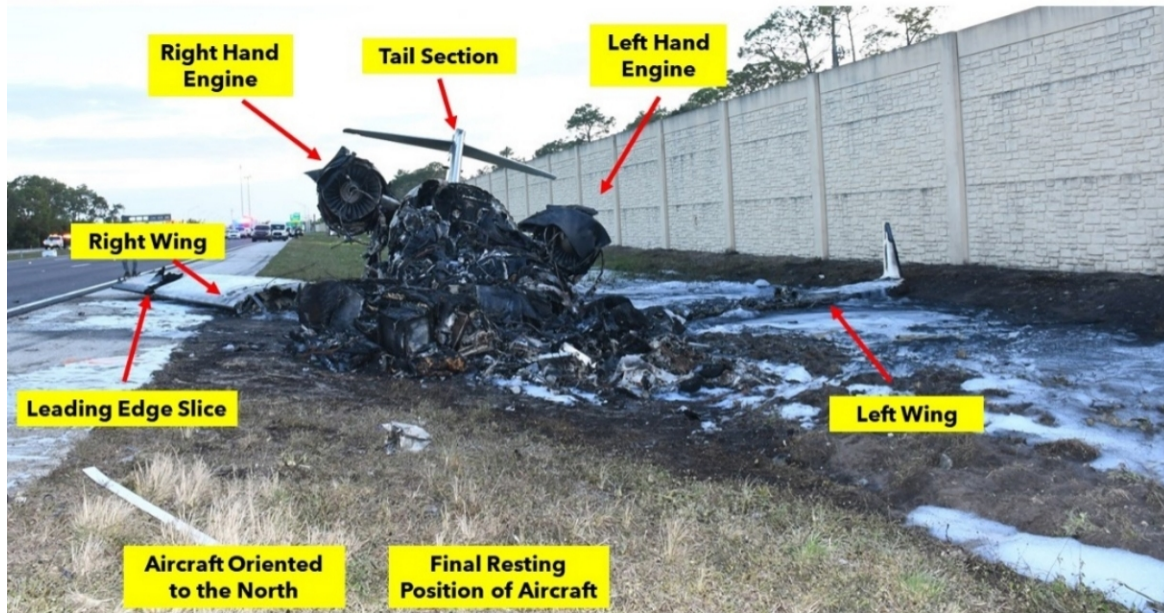
The forward portion of the fuselage was consumed by postimpact fire (see figure 3). All major components of the airplane were accounted for at the scene, and the ground surrounding the wreckage was fuel-soaked, having an odor consistent with Jet A fuel. The cockpit center console was found separated from the main wreckage. Both engine thrust levers were found near the IDLE stop position. The flap selector handle was found in a position consistent with 45° flap extension.

Figure 3. Main wreckage as found.
