# Aviation Investigation Preliminary Report

<b>Location:</b>	Mound, LA	<b>Accident Number:</b>	CEN26FA184
<b>Date &amp; Time:</b>	May 12, 2026, 15:19 Local	<b>Registration:</b>	N251CS
<b>Aircraft:</b>	North American F-51D	<b>Injuries:</b>	1 Fatal
<b>Flight Conducted Under:</b>	Part 91: General aviation - Personal

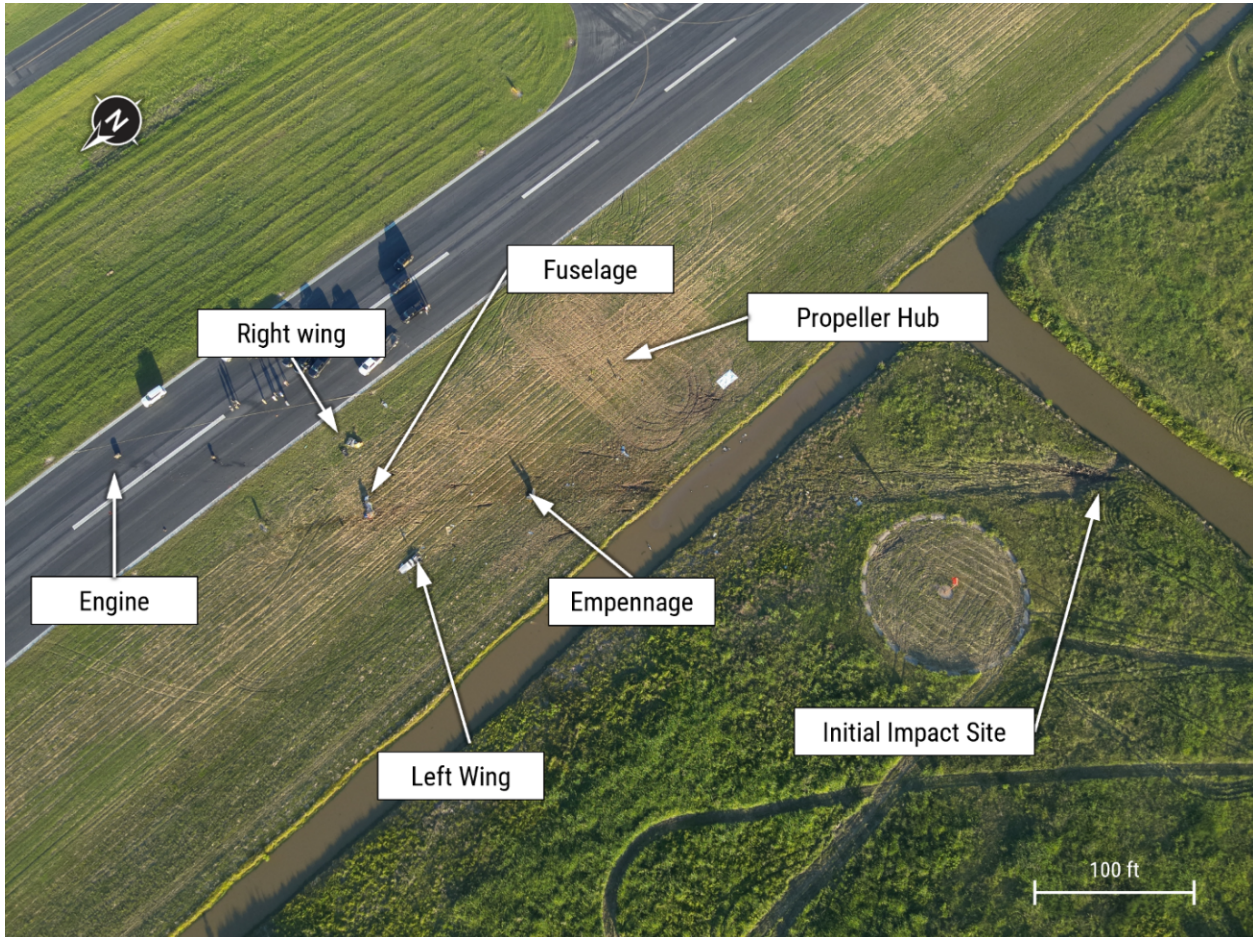
The airplane impacted a drainage embankment about 450 ft west of runway 18/36. The ground scars at the initial impact site were consistent with a high speed, nose level, and right-wing-low attitude. The debris field extended about 920 ft northeast of the initial impact site and was about 200 ft at its widest point. The debris field extended across a 30 ft wide drainage ditch with about 2 to 3 ft of water. All major components of the airplane were found within the debris field.

The cockpit and majority of the fuselage were about 520 ft from the initial impact site as seen in Figure 1. A propeller blade was embedded in the ground at the initial impact site. The engine separated from the airframe and was found about 690 ft from the initial impact site. The cockpit came to rest on its right side on a 300° heading. The debris field was generally aligned on a 40° heading.

Figure 1. Overview of accident site with major components depicted.
