# Interim Report

| Date: | 4 June 2026 |
| Type: | B787-9 |
| State File Number: | BFU26-0454-1X |

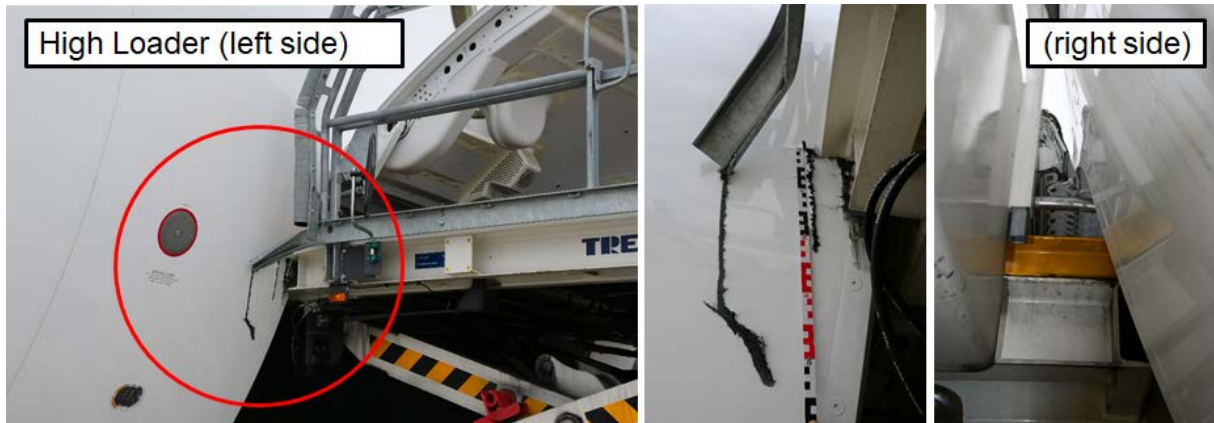
Fig. 4: Fuselage damage at the front cargo door

On the right-hand side, the four doors (1R - 4R) were closed and both cargo doors were open. At the front cargo door stood a High Loader. The High Loader had been pushed down by the fuselage nose and the cargo door.

Figure 4 shows the damage in the area of the front cargo door close to the Static Port (red circle) and a detailed close-up with a scale on the left side of the High Loader. The photo, taken from the right-hand side, shows the bent door mechanism of the front cargo door.

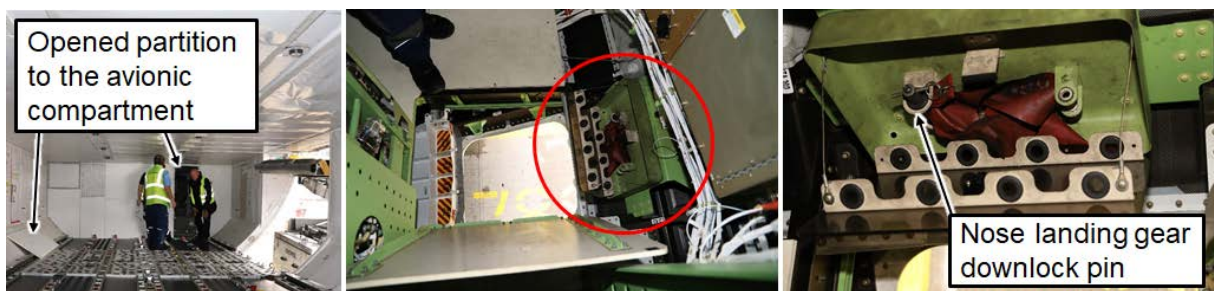
Fig. 5: Opened partition to the avionic compartment in the front cargo compartment

In the front cargo compartment, the partition to the avionic compartment below the cockpit was opened. The storage box for the landing gear downlock pin was stored in the avionic compartment. The landing gear downlock pin for the nose landing gear including the red flag was found inside (Fig. 5).

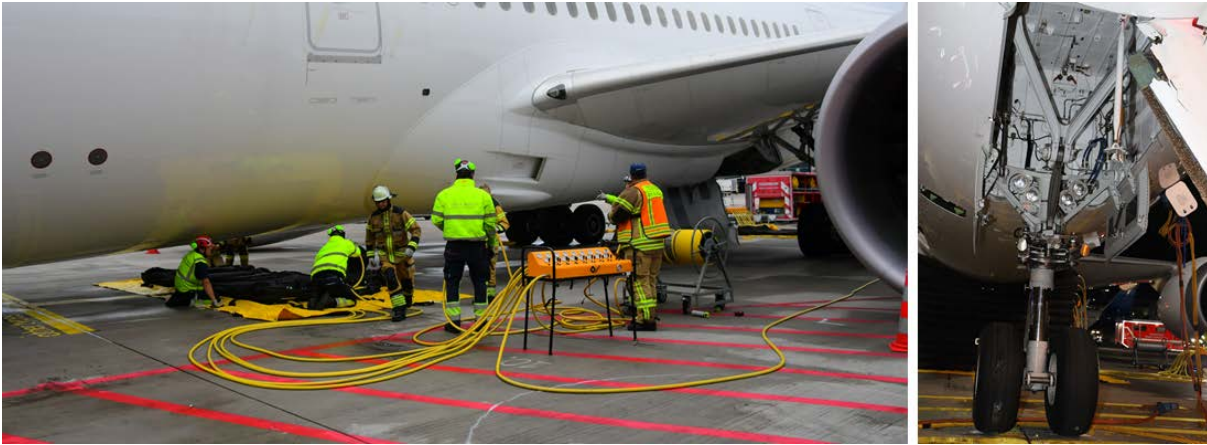
Fig. 6: Aircraft recovery (left) and extended nose landing gear (right)

The operator and the airport fire brigade recovered the aircraft. After power was restored, about 60,000 kg fuel were drained from the fuel tanks. The fuselage nose was lifted up with the help of an air cushion (Fig. 6, left). At about 2 m lifting height, the nose landing gear extended and locked on its own (Fig. 6, right).

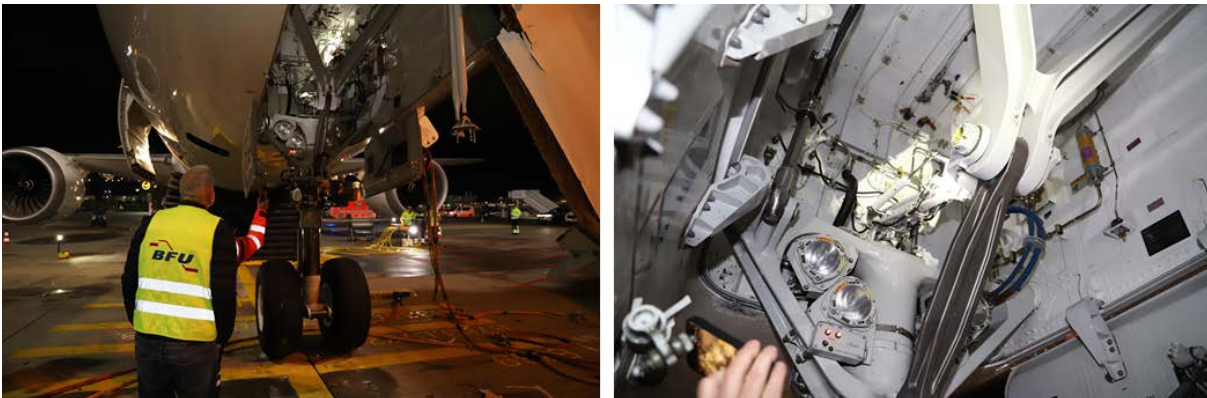
Fig. 7: Documentation of the missing landing gear downlock pin on the nose landing gear of the B787-9

After the aircraft had been lifted up, the BFU documented that the landing gear downlock pin was not inserted into the designated hole on the nose landing gear and was not in the vicinity of the nose landing gear either (Fig. 7).

The nose landing gear was secured with the landing gear downlock pin found in the avionic compartment and the aircraft taken to a hangar for further examination.

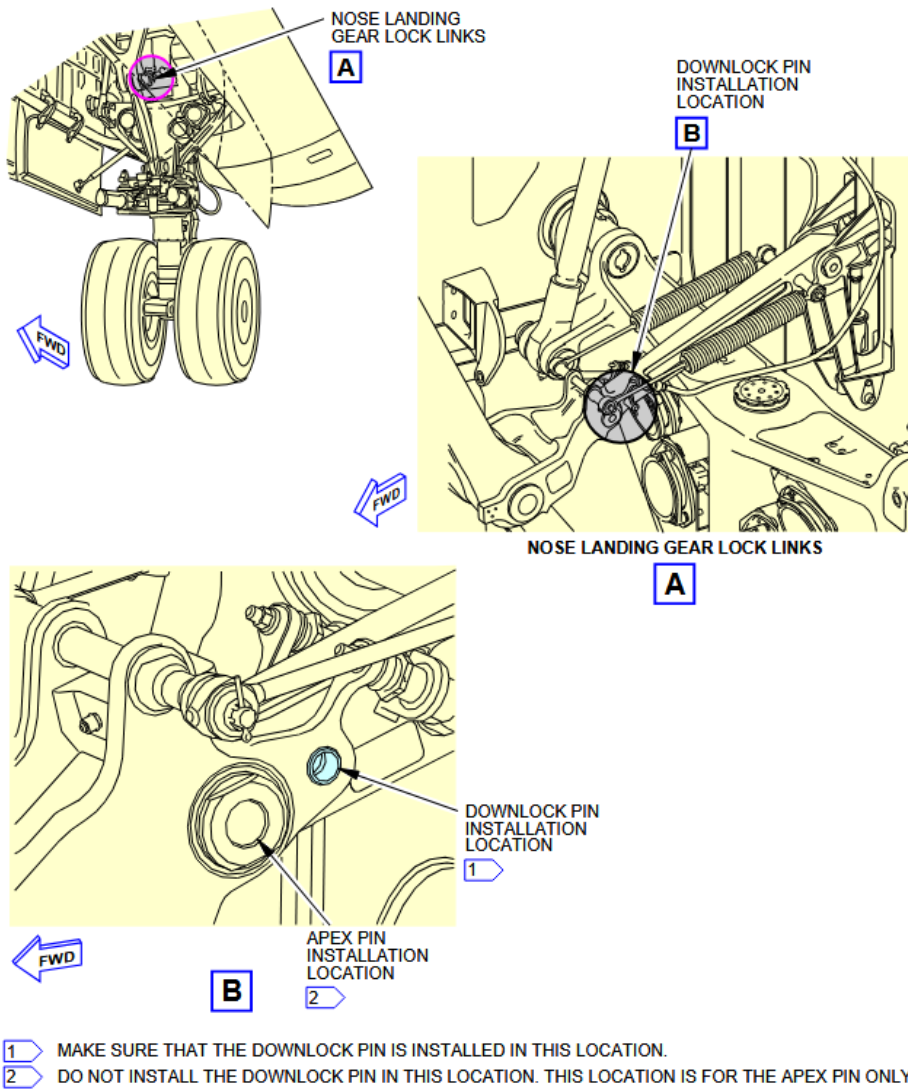
Fig. 9: Excerpt of the Aircraft Maintenance Manual regarding the installation of the nose landing gear downlock pin

Item (5) also referred to the Aircraft Maintenance Manual (AMM)<sup>7</sup>, which described the procedure to secure the landing gear with the landing gear downlock pins. It also depicted the installation of the nose landing gear downlock pin (Fig. 9).
