# Aviation Investigation Final Report

<b>Location:</b>	Hampton, Virginia	<b>Accident Number:</b>	ERA25FA185
<b>Date &amp; Time:</b>	April 24, 2025, 11:35 Local	<b>Registration:</b>	N530RH
<b>Aircraft:</b>	MX AIRCRAFT TECH PTY LTD MXS	<b>Aircraft Damage:</b>	Substantial
<b>Defining Event:</b>	Flight control sys malf/fail	<b>Injuries:</b>	1 Fatal
<b>Flight Conducted Under:</b>	Part 91: General aviation - Personal

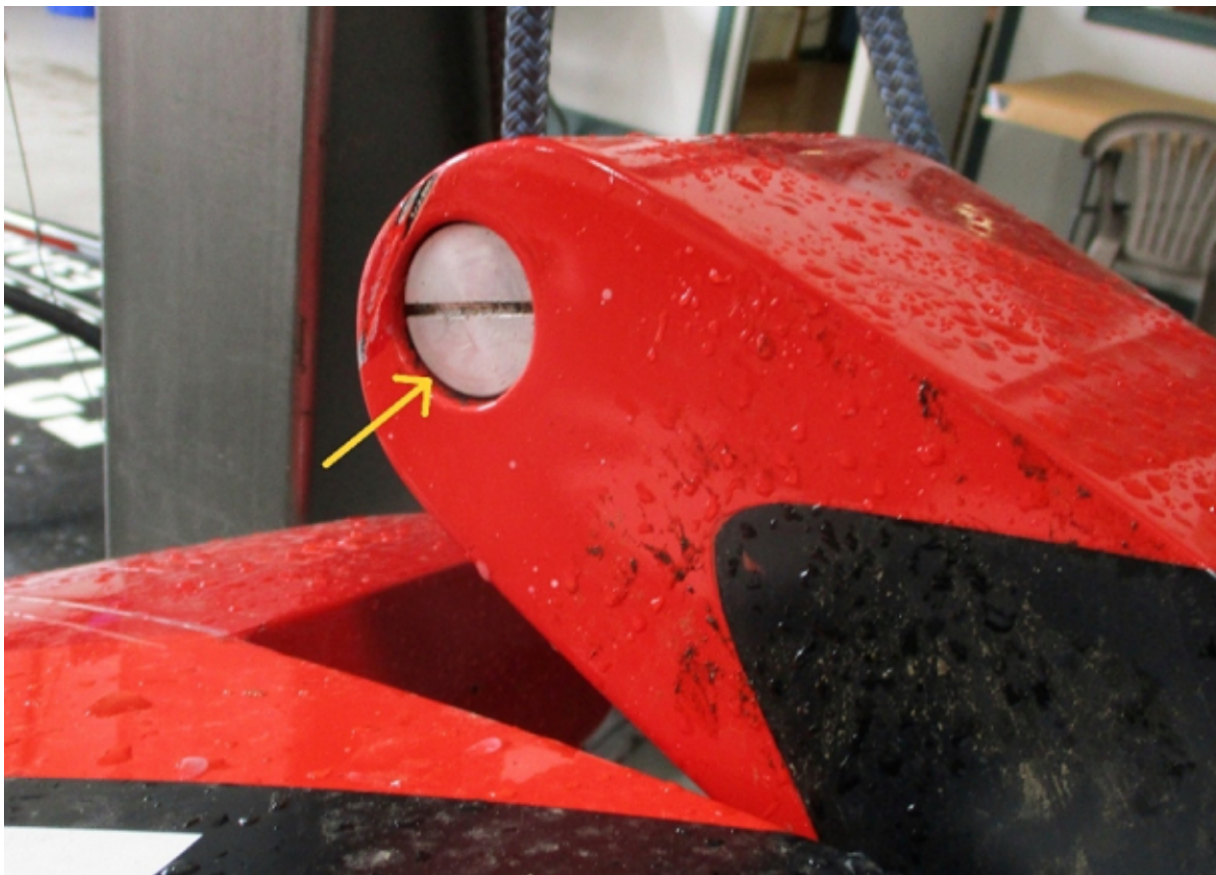
Figure 1. Counterweight plug as installed on the right elevator (postaccident photograph).

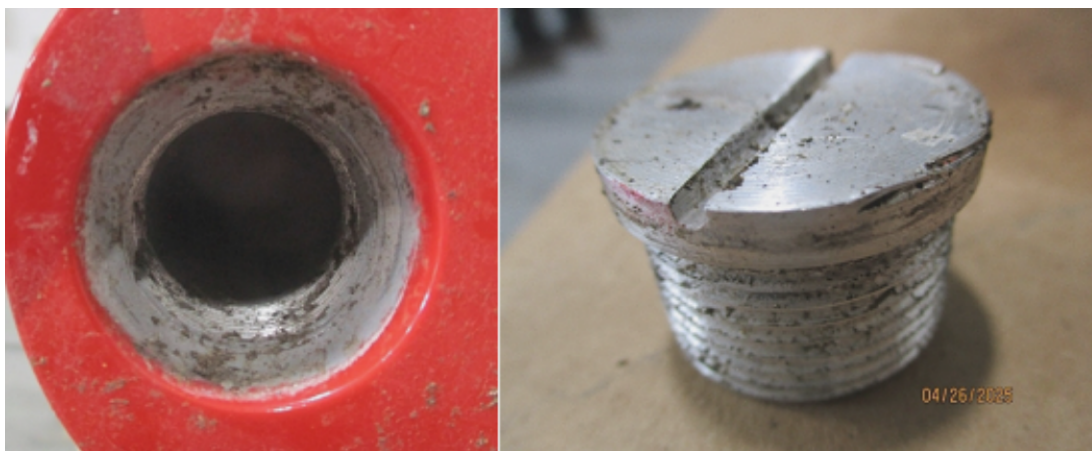
Based on the available information, it is likely that the left elevator counterweight plug loosened during the flight until it made contact with the washer and screw in the horizontal stabilizer, sufficient to jam the elevator. This ultimately resulted in the pilot being unable control the airplane during the landing, and the subsequent impact with terrain.

The wreckage of the airplane came to rest oriented on a heading of 150° in a ditch about 100 ft from the left side of runway 08 and 500 ft beyond the approach threshold. All major components of the airplane were accounted for at the accident site. The left elevator counterweight plug was located about 10 ft behind the wreckage in the grass.

Postaccident examination revealed that dirt consistent with that found in the vicinity of the accident site was identified on the elevator, as well as in the counterbore and threaded area where the left elevator counterweight plug would have been installed. The counterweight plug threads were intact and also contained similar dirt contamination consistent with that found on the elevator. About half the circumference of the left elevator counterweight plug displayed gouging, and an area showed evidence of paint transfer (see figure 2). No o-ring associated with the left elevator plug was found. The right elevator counterweight plug remained installed and was tight. It was removed and found to contain no o-ring.

Figure 2. Left elevator counterweight installation hole (left) and recovered counterweight plug (right). Gouging and paint transfer are visible on the counterweight plug.

Following the accident, the airframe manufacturer published an undated Mandatory Safety Notice (SN 2025-01), which was applicable to MXS and MX2 airplanes fitted with adjustable balance tubes, and provided instructions for filling existing adjustable balance tubes with a lead/resin mixture.

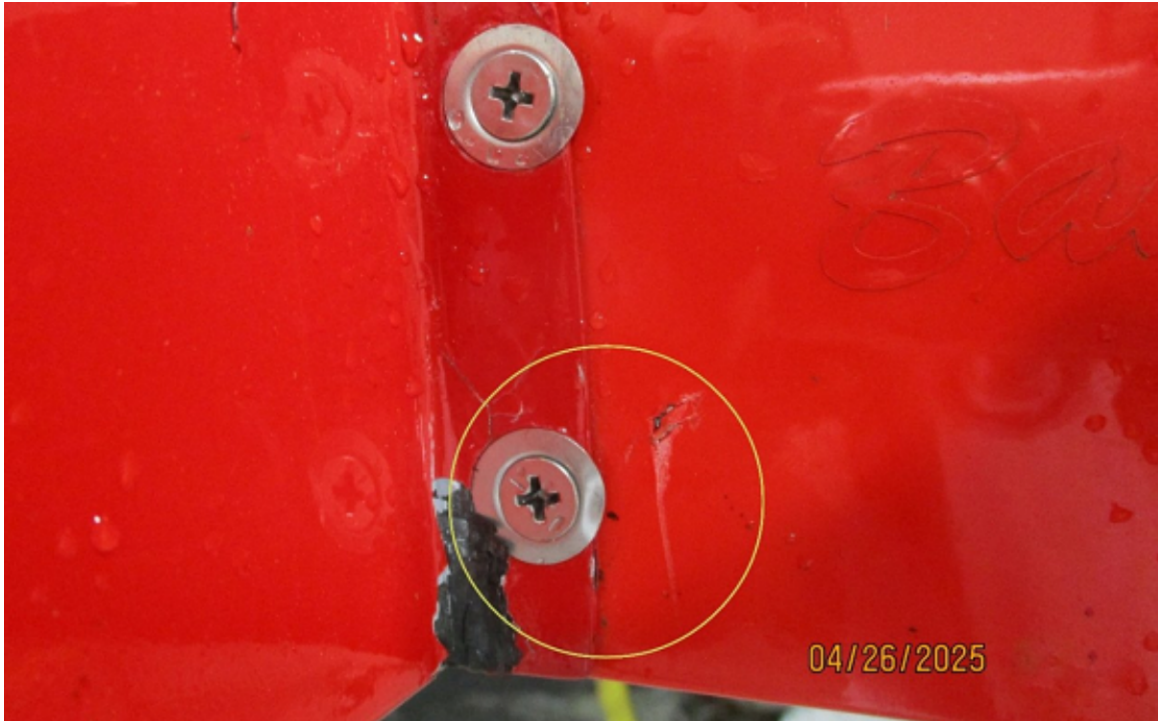
The horizontal stabilizer structure adjacent to the elevator position where the counterweight plug would have been installed displayed dents and paint scrapes that appeared visually consistent with contact with the counterweight plug. A washer beneath a stainless steel screw secured to the horizontal stabilizer structure (near where the paint scrapes were observed) was also dented (see figure 3).

Figure 3. Horizontal stabilizer structure adjacent to the left elevator counterweight plug, showing paint scrapes and a dented washer (circled in yellow).

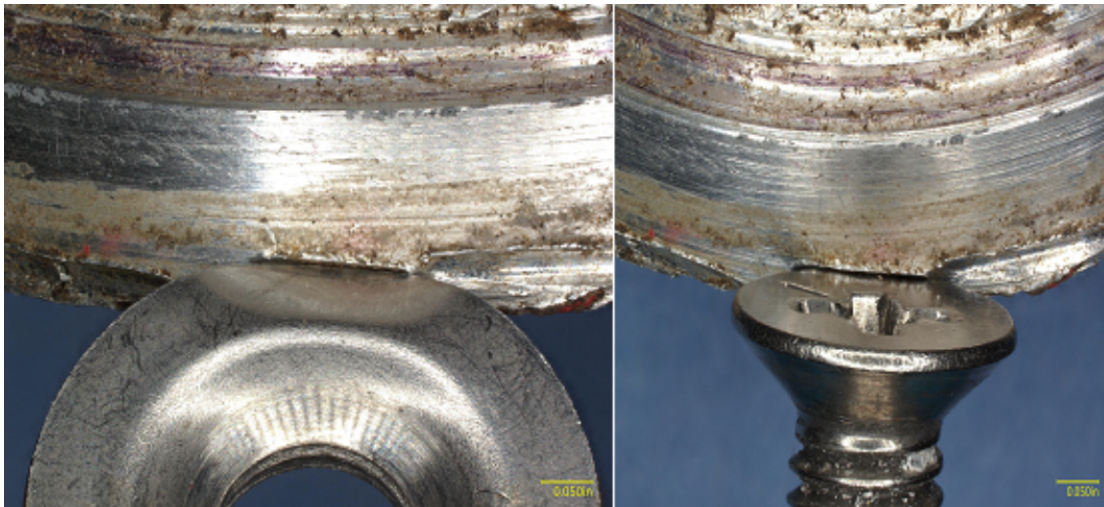
The counterweight plug, washer, and screw were sent to the NTSB Materials Laboratory for further examination. Metallurgical examination revealed that both the washer and screw had thickness profiles that matched the marks in the outer diameter edge on the aluminum plug and that the marks were consistent with the washer having made repeated contact with the aluminum plug (see figure 4).

Figure 4. Impression marks on the counterweight plug consistent with contact with the washer (left) and screw (right).
