Aviation Investigation Preliminary Report

Location:	Lincoln, NM	**Accident Number:**	WPR26FA186
Date & Time:	May 14, 2026, 00:15 Local	**Registration:**	N249CP
Aircraft:	Beech C90	**Injuries:**	4 Fatal
Flight Conducted Under:	Part 135: Air taxi & commuter - Non-scheduled

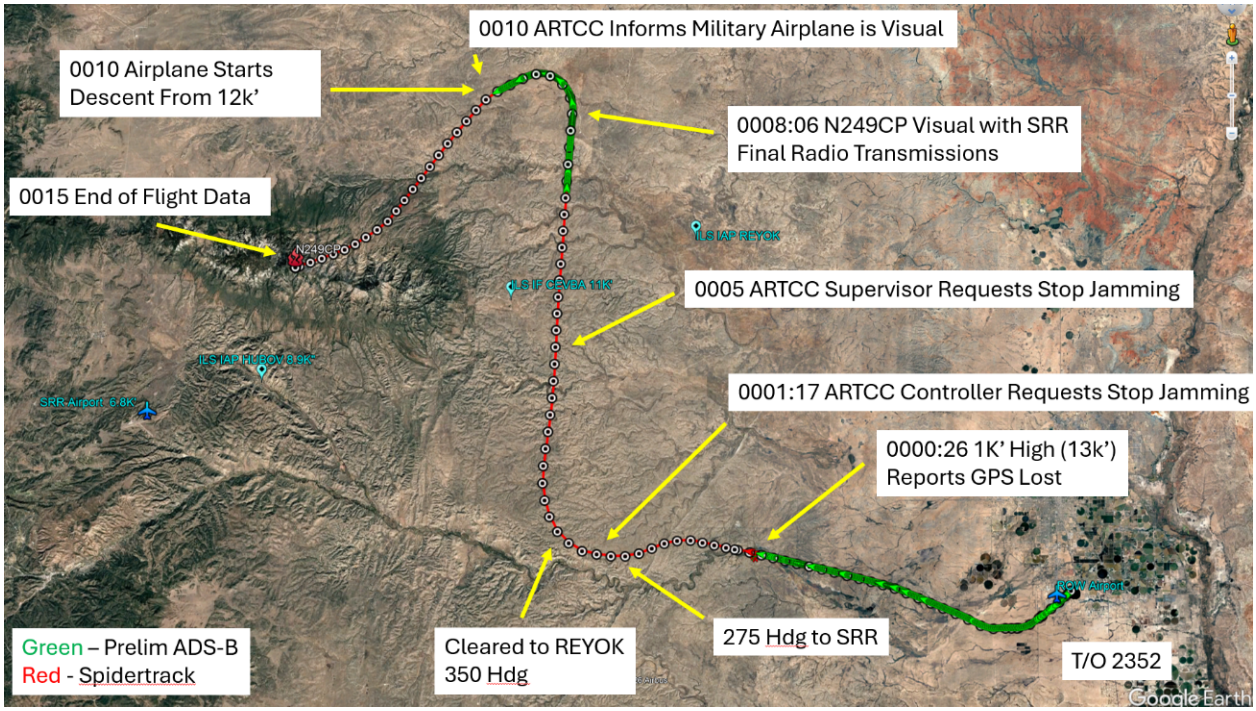
Figure 1: Flight Path with Key Communications

The airplane was equipped with Spidertracks flight tracking equipment which reported GPS generated altitude, heading, airspeed, and position for the duration of the accident flight. Additionally, ABS-B data captured portions of the accident flight. The data from both sources were consistent with each other, except the recorded Spidertracks GPS altitude was generally about 600 ft higher than the recorded ADS-B altitudes and there were large gaps in the recorded ADS-B data. See Figure 1 for a flight path depiction and summary of key communications.

About 0010, the ARTCC operations supervisor informed [the military] that the airplane was on a visual approach and that they could resume jamming. At 0010:27 ADS-B again began collecting data at about one-minute intervals. About the same time, the airplane began descending toward SRR followed by a slight right turn at 0013:26 and 9,820 ft Spidertrack GPS altitude.

The airplane continued to descend until about 0014:45 when the airplane climbed from about 9,400 ft Spidertrack GPS altitude until the last Spidertrack data point at 0015:26 recorded the airplane at 9,823 ft Spidertrack GPS altitude, 150 kts groundspeed, and a true heading of 250°.

The airplane impacted terrain about 250 ft southwest of the last recorded data point at an elevation of about 9,950 ft, and about 730 ft east and 230 ft below the Capitan Mountains Summit Radio Facility, located at an elevation of about 10,180 ft. A post impact fire occurred that initiated a forest fire.
