Factual Information

History of Flight

On January 3, 2022, 1134 Pacific Standard Time, I departed the Riverside Municipal Airport (KRAL) with the intent of maintaining proficiency on takeoff and landings at the local airport I teach out of, Cable Airport (KCCB) on N76646, a Cessna 120.

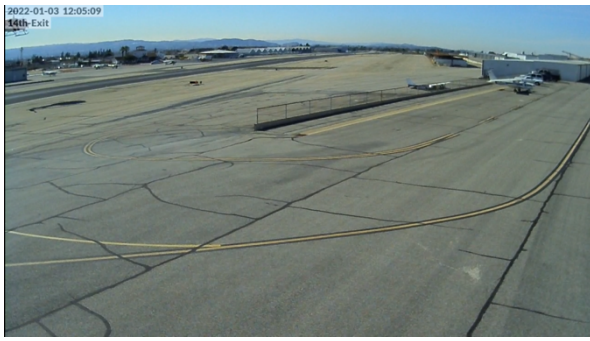
First Frame of Huey Helicopter N306SB

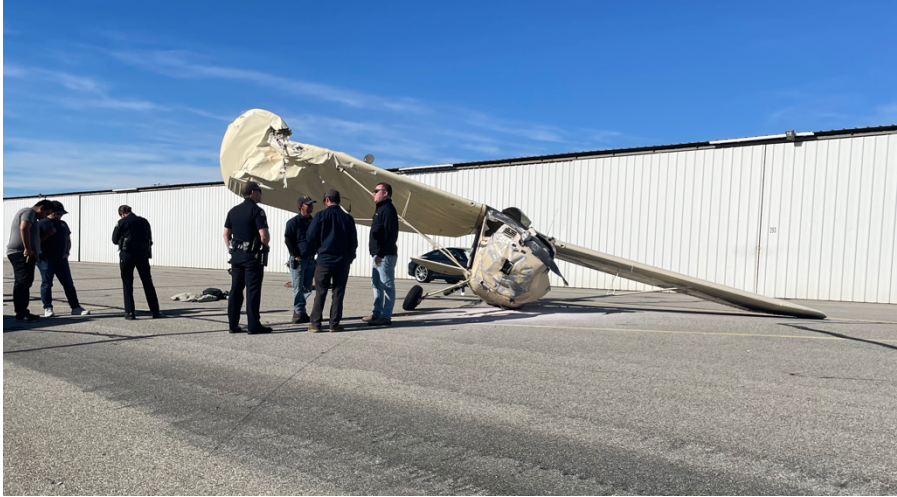
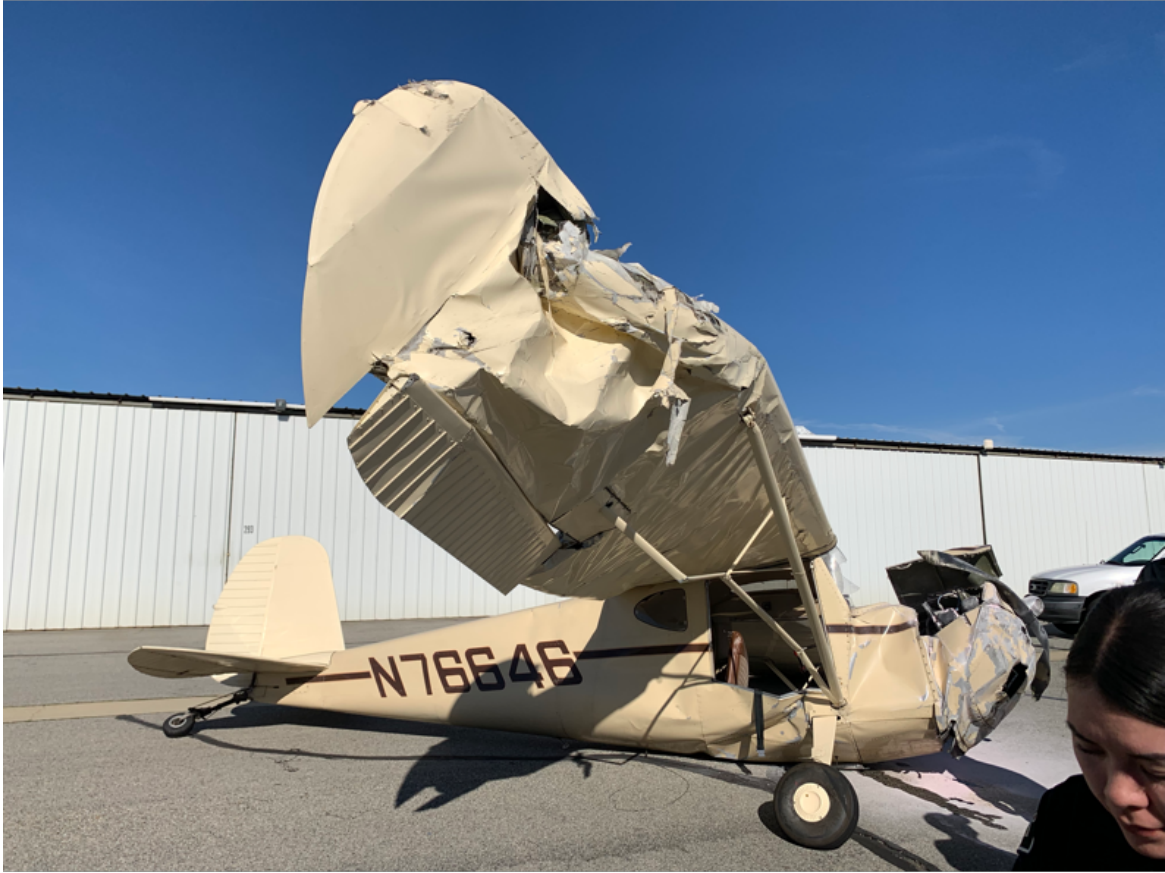
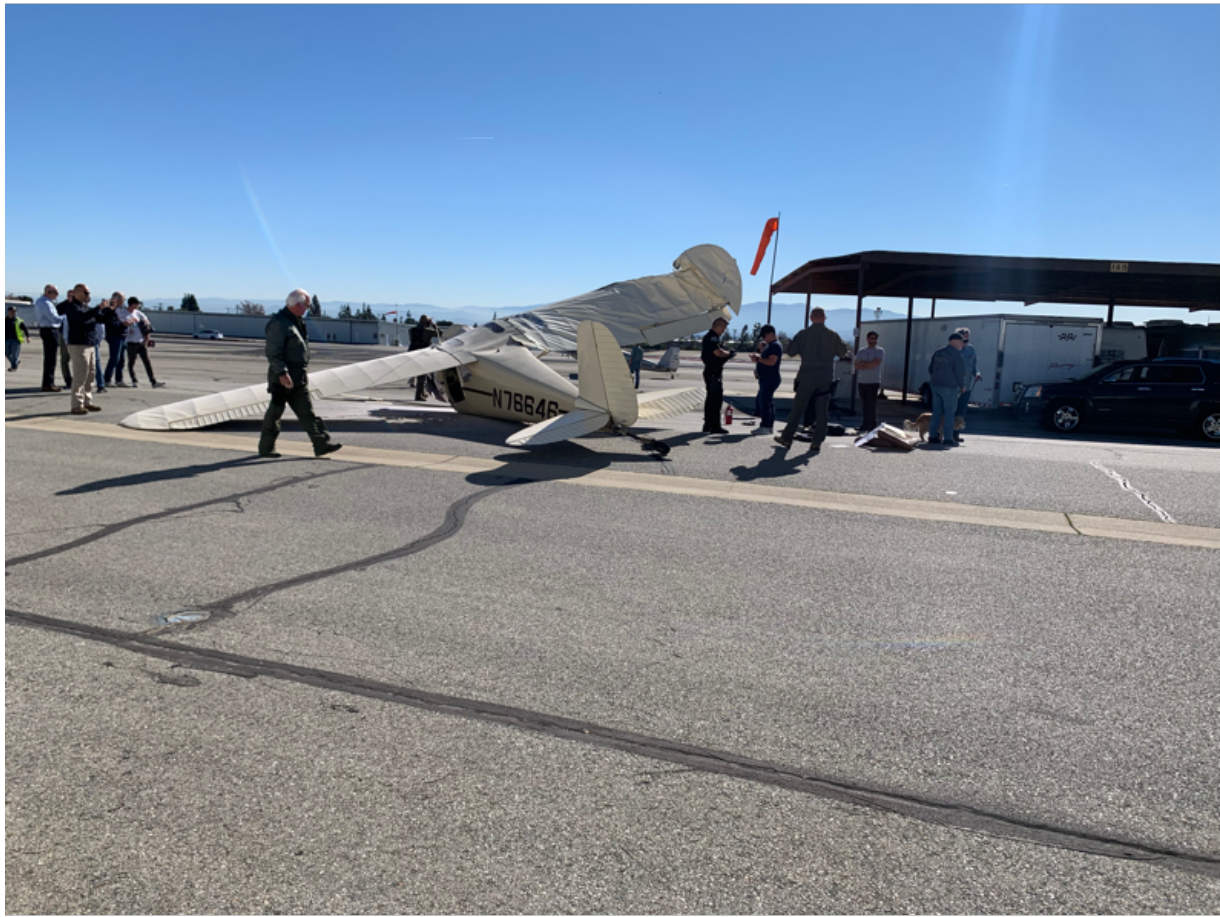
Aircraft Banked 90° to the right seconds prior to impact.

On January 3th, 2022, 1205 Pacific Standard Time, a Cessna 120 airplane, N76646, impacted the asphalt north of runway 24 at Cable Airport in an attempted go around. Loss of Control can be attributed due to Rotor wash from N306SB, a San Bernardino Sheriff's Huey Helicopter who did not announce intentions of crossing runway 24, crossed an active runway when the pilot of N76646 was on final. The rotor wash did not allow for the safe execution of a go around.

Recommendations

This accident could've been prevented if the operator of N306SB followed the noise abatement procedures for the Cable Airport. By avoiding a long straight in approach that set up the helicopter south of the extended centerline, and instead entering traffic pattern like other aircraft, this would've helped with the flow of traffic and separation. It is unclear if N306SB had intents of landing, or purpose of their flight or operations, but if they wanted to use the runway, they should broadcast their intentions on the CTAF like everyone else.

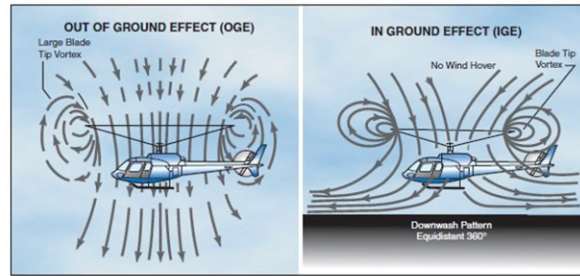
Figure 3-5: Air circulation patterns change when hovering out of ground effect (OGE) and when hovering in ground effect (IGE)
