ACCIDENT

Aircraft Type and Registration:	Piper PA-46-350P (Modified), G-HYZA	
No & Type of Engines:	2 YASA electric motors (common shaft)	
Year of Manufacture:	1997 (Serial no: 4636130)	
Date & Time (UTC):	29 April 2021 at 1425 hrs	
Location:	Near Cranfield Airport, Bedfordshire	
Type of Flight:	Other	
Persons on Board:	Crew - 2	Passengers - None
Injuries:	Crew - None	Passengers - N/A
Nature of Damage:	Left wing detached, landing gear collapsed and nose cowl distortion	
Commander's Licence:	Airline Transport Pilot's Licence	
Commander's Age:	63 years	
Commander's Flying Experience:	34,620 hours (of which 1,588 were on the basic type, 12 were on the modified electric variant) Last 90 days - 59 hours Last 28 days - 19 hours	
Information Source:	AAIB Field Investigation

Synopsis

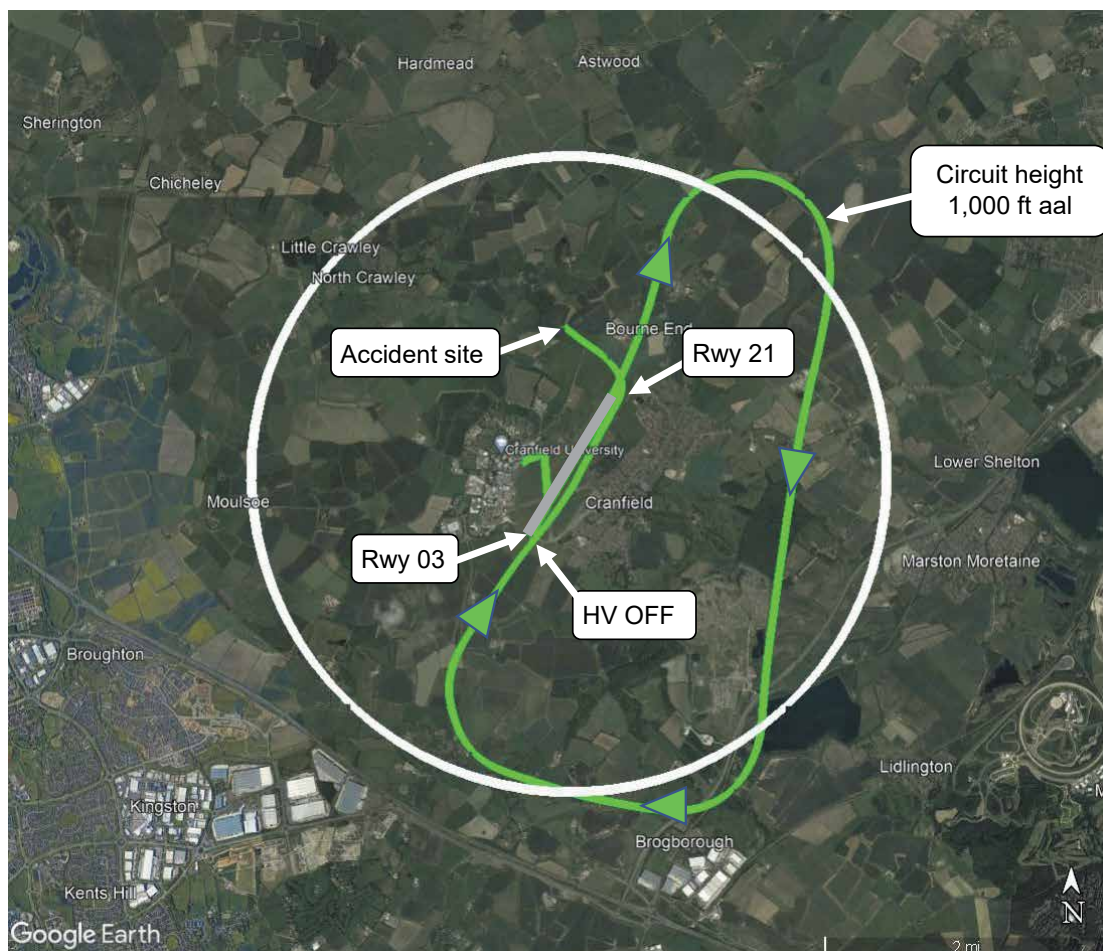
Figure 1

G-HYZA track overview (green).
White circle depicts 2 nm boundary of the flight test area

After takeoff, the aircraft achieved an average vertical speed of approximately 425 ft/min. Circuit altitude of 1,300 ft amsl (approximately 1,000 ft aal¹²) was achieved just under three minutes after takeoff at the start of the downwind leg. Airspeed data was not recorded but the ASI could be read using the cockpit video recording. During the crosswind leg, the aircraft track extended beyond the 2 nm boundary (see Figure 1).

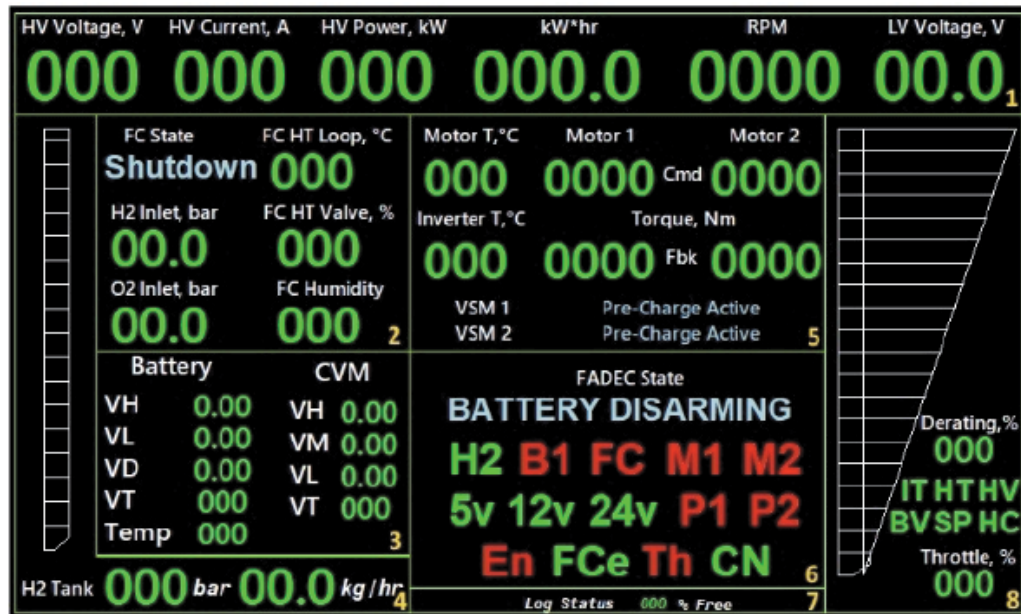
Figure 5

The pilot's display had a viewable area of 175 mm x 110 mm. It showed 28 parameters and 24 status, caution or warning captions in a variety of font sizes down to 4.5 mm (Figure 5).

Parameters displayed on pilot's powertrain electronic cockpit display

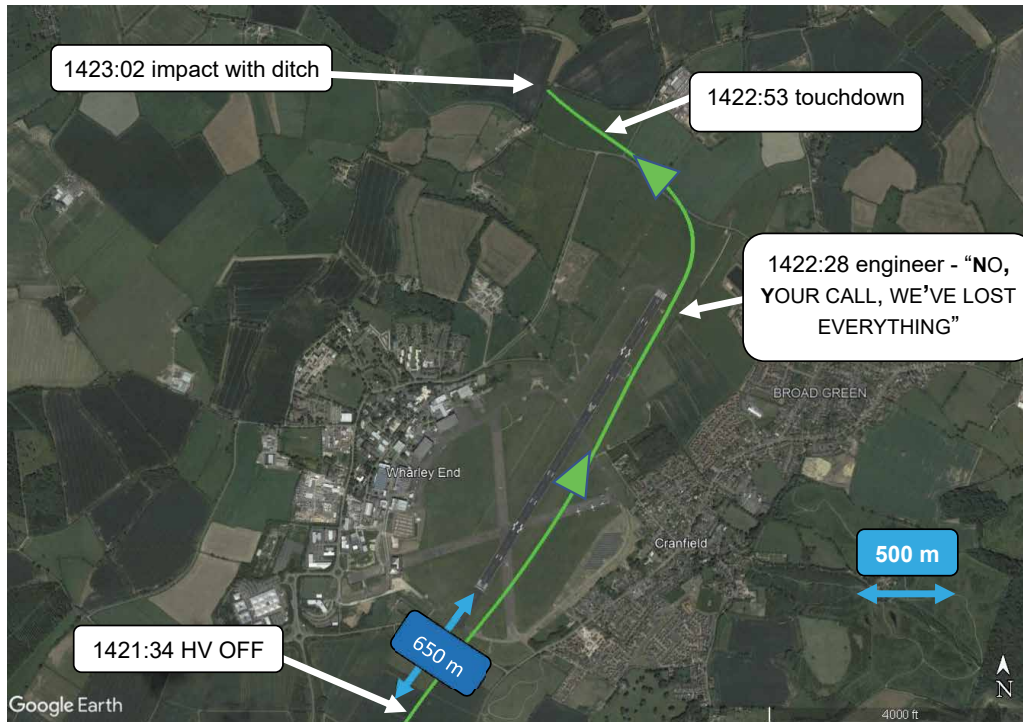
Figure 9
G-HYZA track

At 1421:34 hrs, the pilot selected the HV battery OFF using a switch in the overhead panel. The aircraft was located 650 m (Figure 9) from the displaced threshold of Runway 03 at 1,300 ft amsl (942 ft aal).
