SAIB: 2024-02
Date: April 4, 2024

SUBJ: Wing Spar

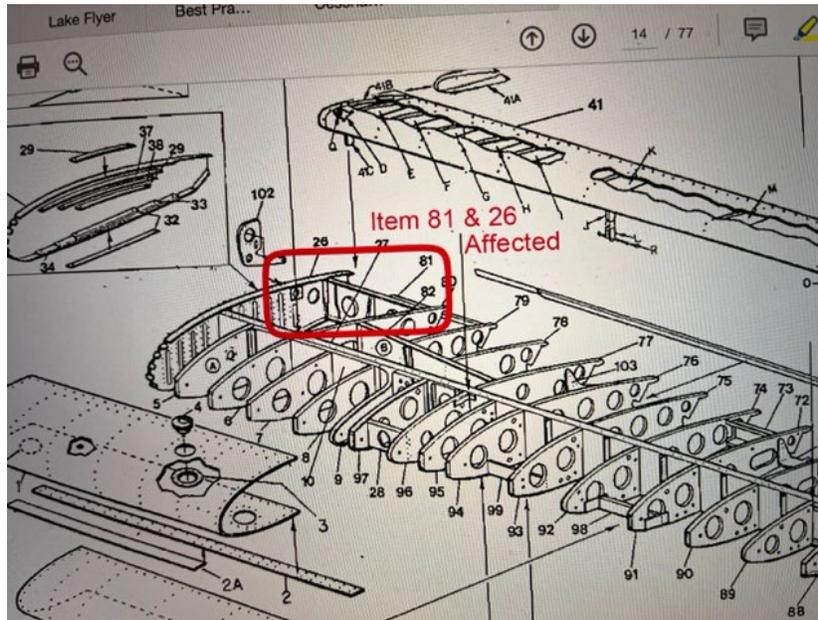
Figure 4
Lake Model 250 Renegade Manual
Root Rib (Item 26) and Rear Attach Beam Assy (Item 81)

2. Inspect all wing attach fittings for security, wear, corrosion, damage, and condition of sealant at fuselage.
3. Inspect wing aft beam assembly for damage, distortion, corrosion, and general condition. Perform close visual inspection around the lightning holes near the large cut out in the aft web. Look for indications of cracking as shown in the pictures above.

6. If cracks, gaps, or elongated holes are found, repair or replace parts in accordance with the manufacturer's instructions, or using other methods, techniques, and practices acceptable to the Administrator provided in FAA Advisory Circular [AC 43.13-1B](#)
